Post Flood Bridge Inspection Form

Bridge File Number	01741-1 ✓	Inspector Name	J. RUSSO
Location Description	HIGHWOOD RIVER BRIDGE ON HIGHWAY 22, 1 KM S OF LONGVIEW ✓	Assistant Name	
		Inspection Date	13-JULY-2013
Legal Land Location	NE SEC 17 TWP 18 RGE 2 W5M ✓		
Longitude; Latitude	-114.234062; 50.522899 ✓		
Unique Span Types	PO, CS ✓

File No.	01741
Date	July 13, 2013
Photos By	J. Rusu
Stream/Highway/Location	Highwood River / Hwy 22 / Longview

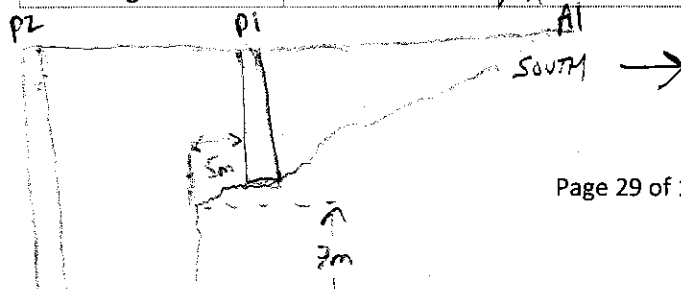
Abutment Backwall	NO VISIBLE DAMAGE
Abutment Wingwall	NO VISIBLE DAMAGE
Abutment Piles	NOT VISIBLE
Abutment Stability	STABLE ABUTMENTS. NO SIGNS OF FLOOD RELATED INSTABILITY.
Abutment Scour/Erosion	EROSION AT NORTH HEADSLOPES - NOT FLOOD RELATED AND APPEARS STABLE
Pier Piles	NOT VISIBLE
Pier Stability	NO LEANING OR TIPPING. PIER STABILITY LOOKS O.K.
Pier Scour/Erosion	EROSION AT SOUTH PIER (PIER 1) IS SEVERE SEE PHOTOS + SKETCH BELOW.
Pier Bracing/Struts/Sheathing	N/A

APPROX. 50m LONG & ALIGNED W/ CHAN
 APPROX. 25m LONG U/S + SOUTH
 OF BRIDGE.

Other Item	
Other Item	
Other Item	
General Comment	PROTECTION BE AND REPAIR OF SOUTH PIER SLOPE RECOMMENDED.

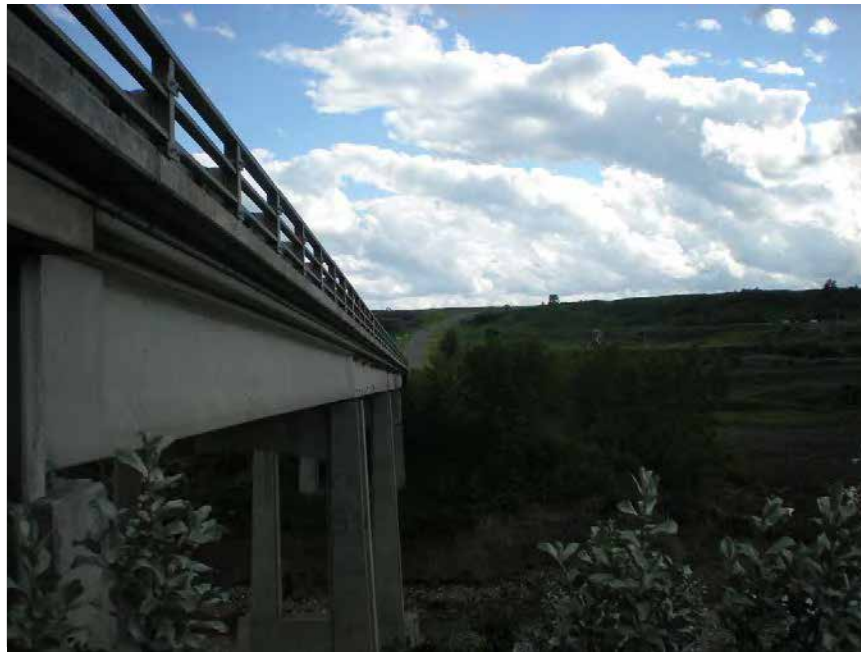
Photo 1
From NW abut. embankment looking south at west girder line. Horizontal and vertical alignments are good.

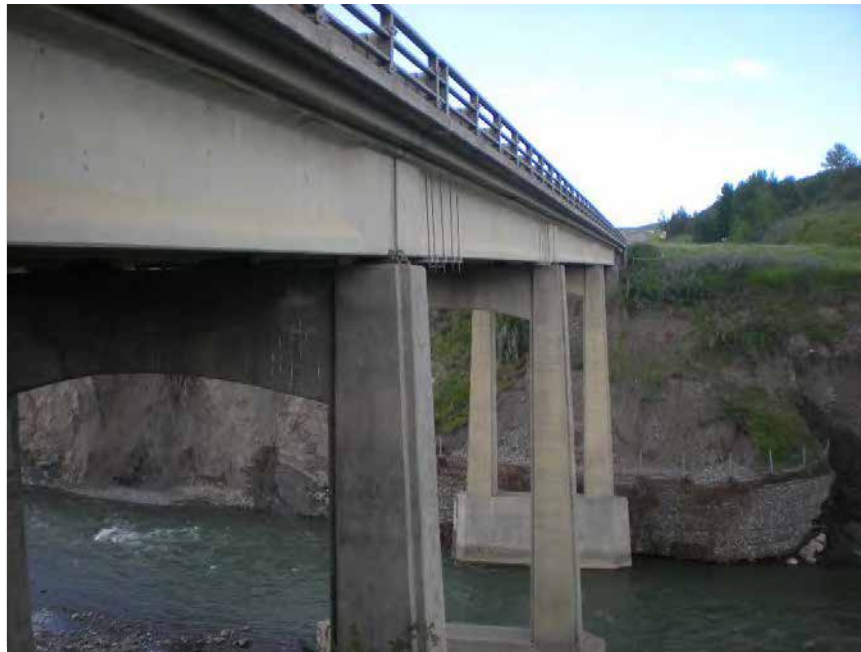
Photo 3: From SE abut. embankment looking north at east d/s girder line. Horizontal and vertical alignments are good. Gabions in place at north headslope but may be missing riprap at U/S end.

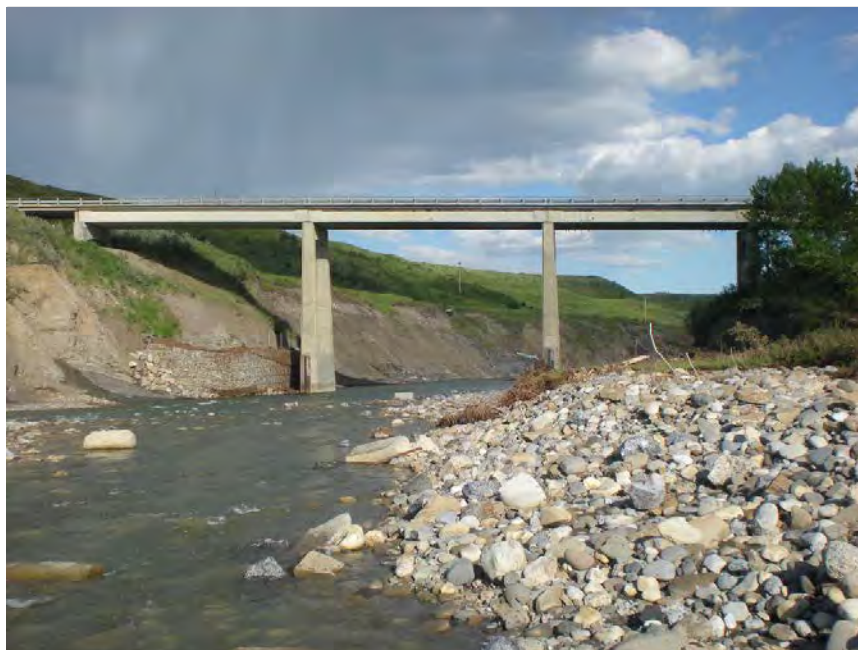
Photo 4
From SW bank looking d/s at bridge. Vertical alignment looks good.

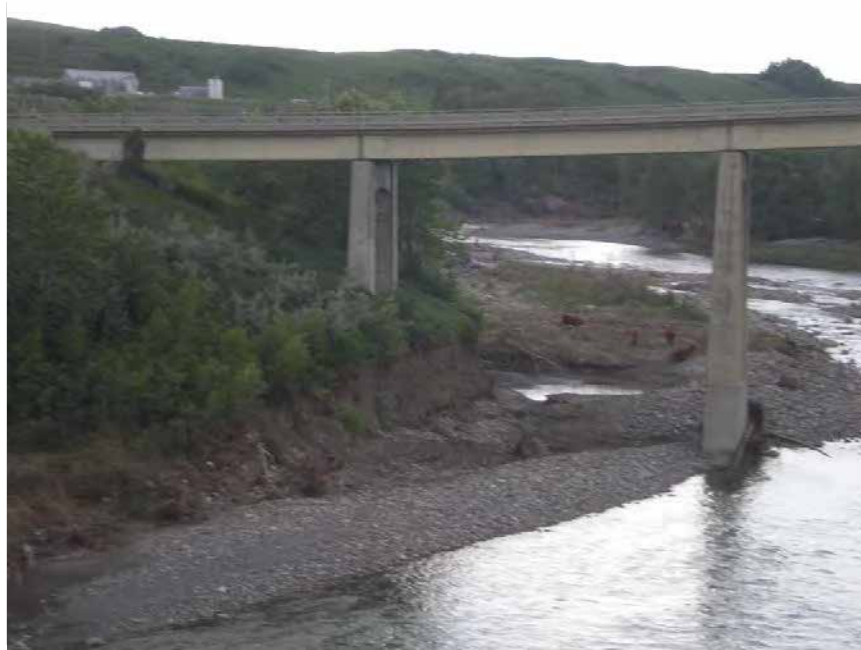
Photo 5
Looking u/s from NE bank at P1 and P2, note erosion under P1.

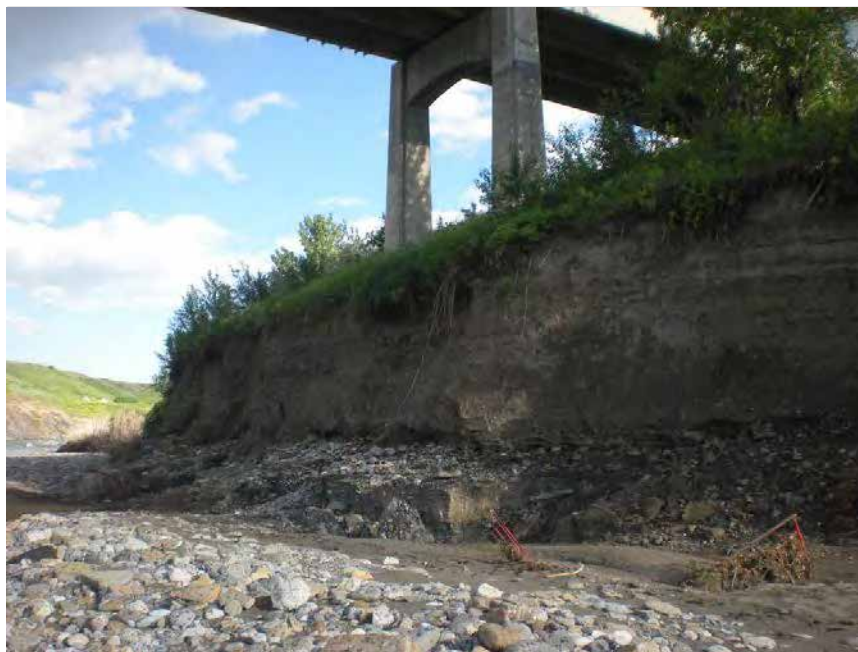
Photo 6
Looking d/s from SW bank at erosion at south headslope - beneath P1.

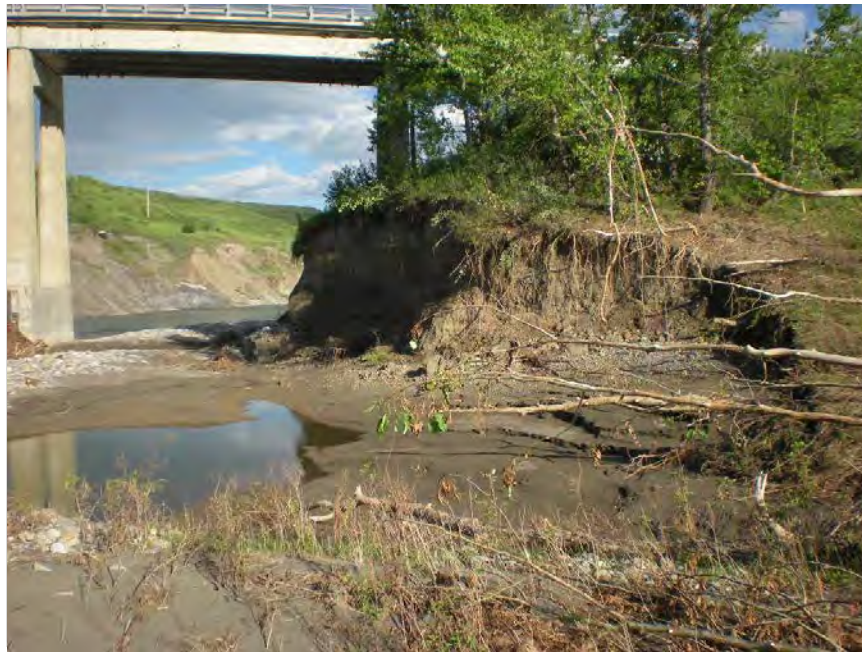
Photo 7
Looking d/s from SW bank at extent of erosion around
SW corner.

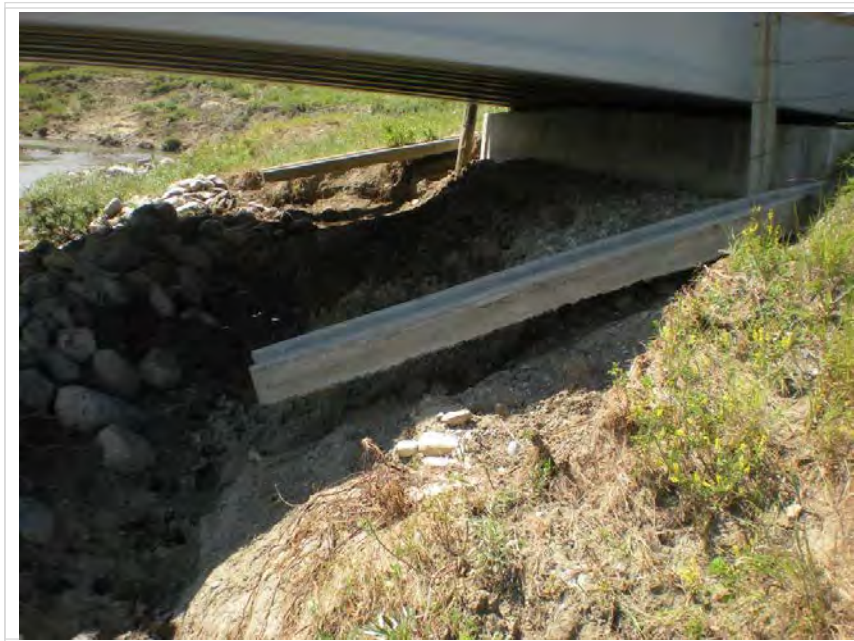
Abutment Backwall	NO VISIBLE FLOOD DAMAGE
Abutment Wingwall	NO VISIBLE FLOOD DAMAGE
Abutment Piles	NOT ACCESSIBLE
Abutment Stability	STABLE ABUTMENTS
Abutment Scour/Erosion	SCOUR DUE TO HIGH WATER AND/OR CATTLE TRACKING AT NORTH HEADSLOPES. NE + NW DRAIN TROUGHS COMPLETELY UNDERMINED.
Pier Piles	NO PIERS
Pier Stability	N/A
Pier Scour/Erosion	N/A
Pier Bracing/Struts/Sheathing	N/A

Photo 5
North headslope erosion and hanging drain troughs -
replacement fill and scour protection required.

Other Item	
Other Item	
Other Item	
General Comment	EROSION REPAIRS AT DRAIN TROUGHS AND ADDITION OF SCOUR PROTECTION AT NORTH ABUTMENT HEADSLOPE RECOMMENDED.

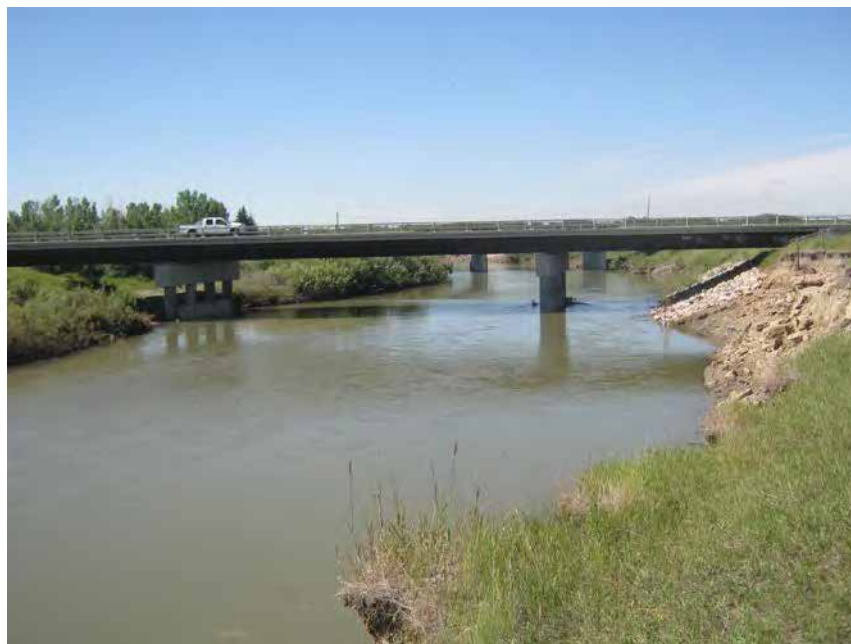
Photo 7 Looking u/s at bridge from n.w. bank- scour at n.w. bank.

2014 - 6 ROOM + RIP RAP N.E. BANK
2014

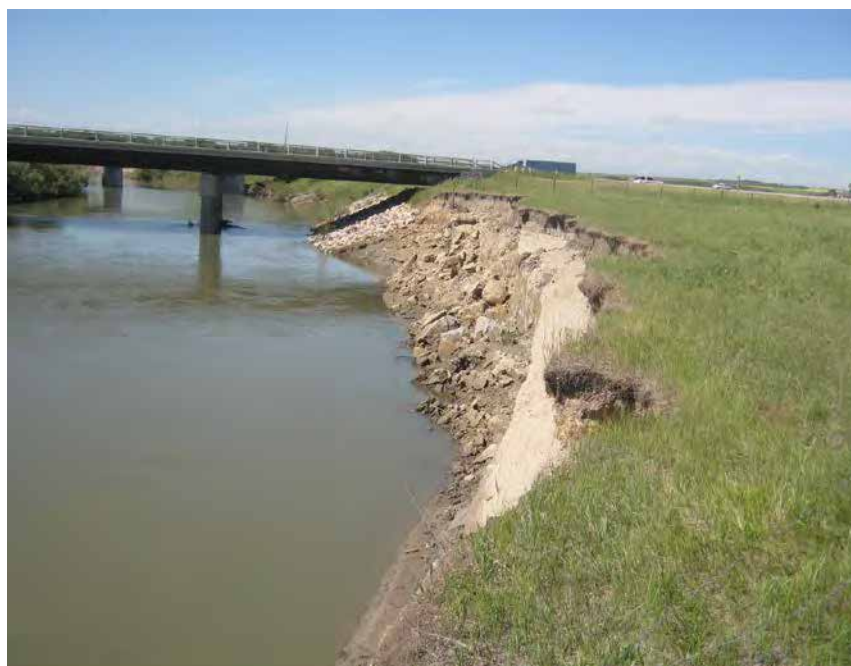
Photo 8 Scour at n.w. bank looking south towards bridge.

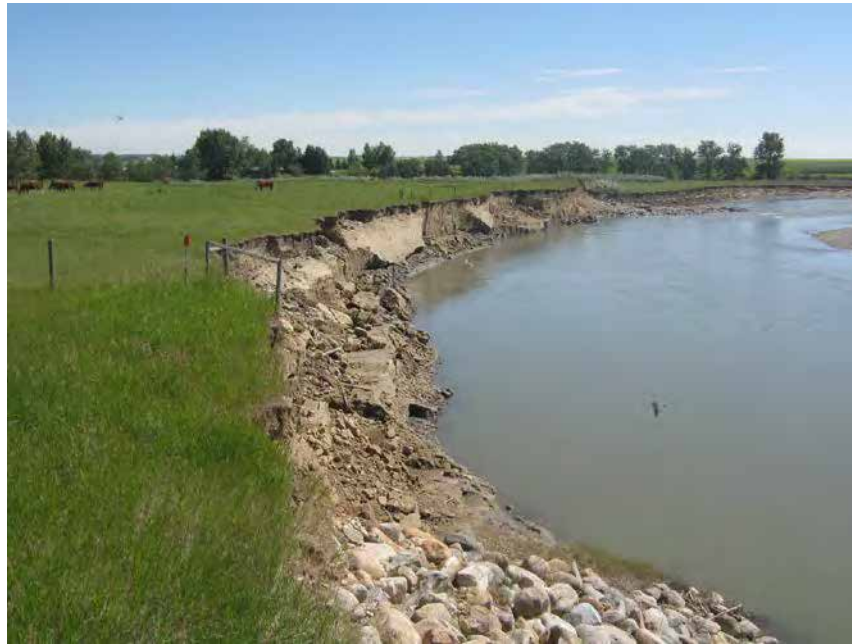
Photo 9 Scour at n.w. bank looking north from bridge.

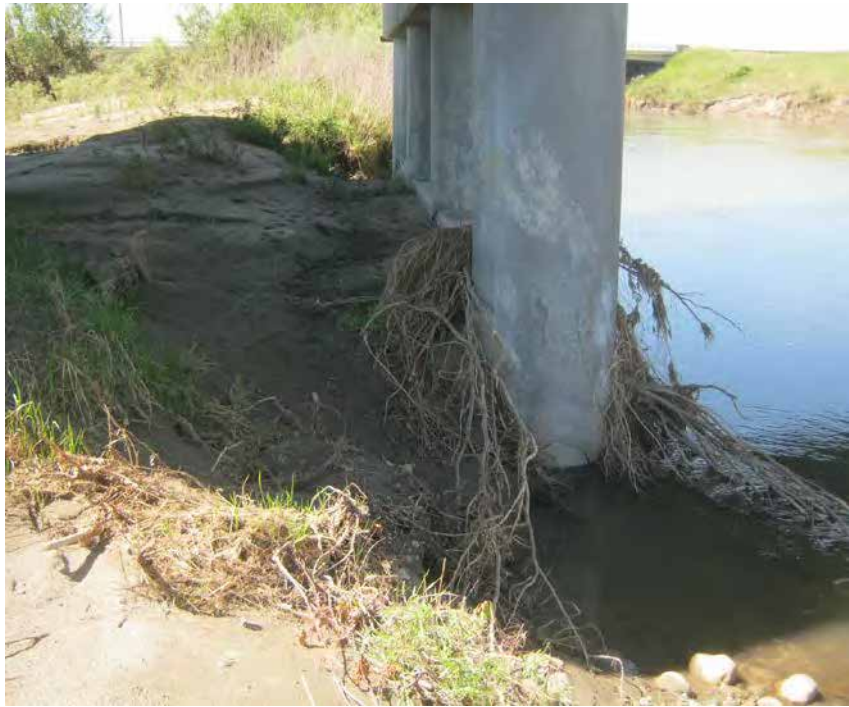
Photo 11 Localized scour at ends of P2.

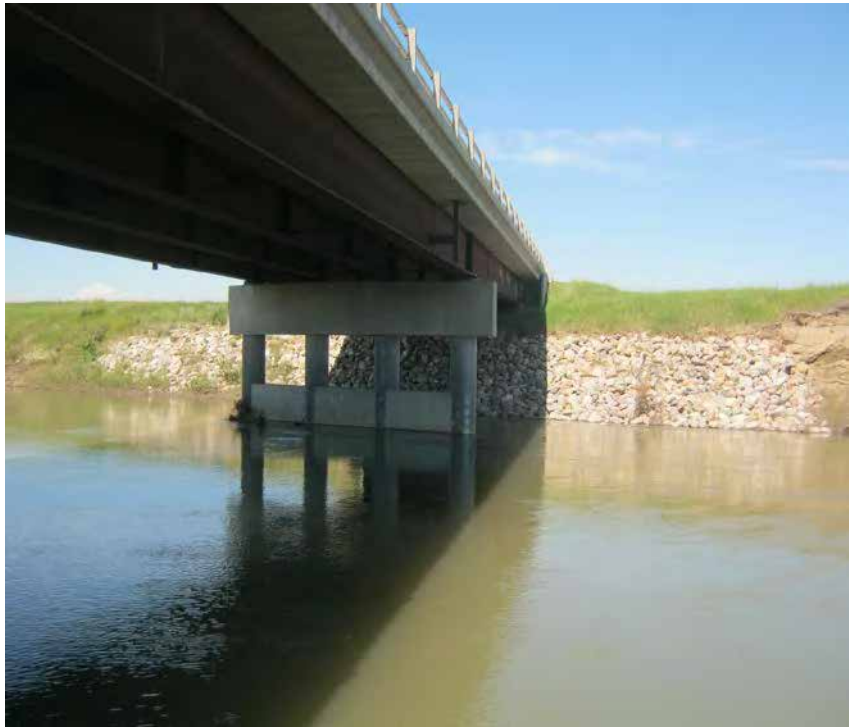
Photo 12 Intact rip rap at A1.

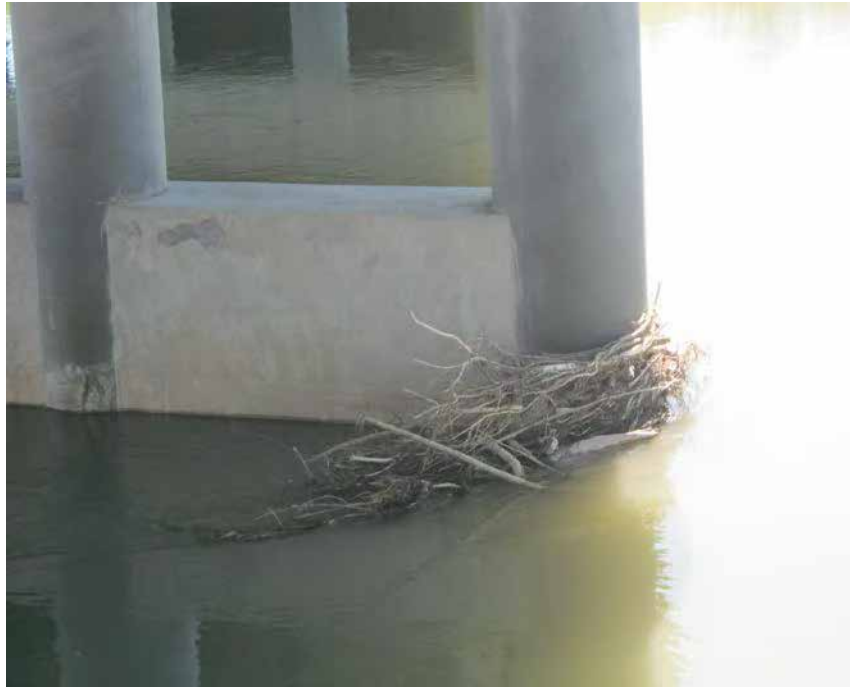
Photo 13 Drift at P1.

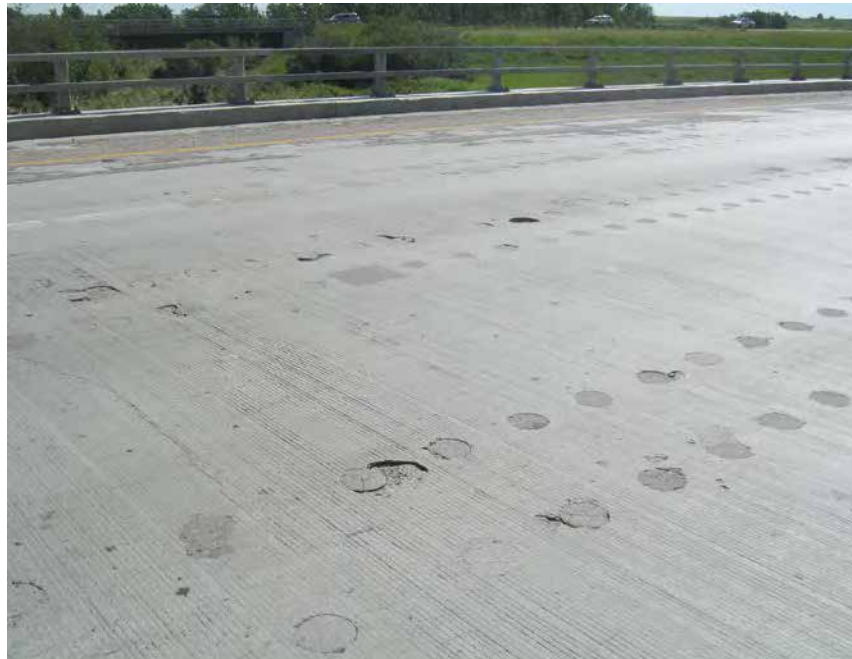
Photo 8 Patched core hole spalls in deck.

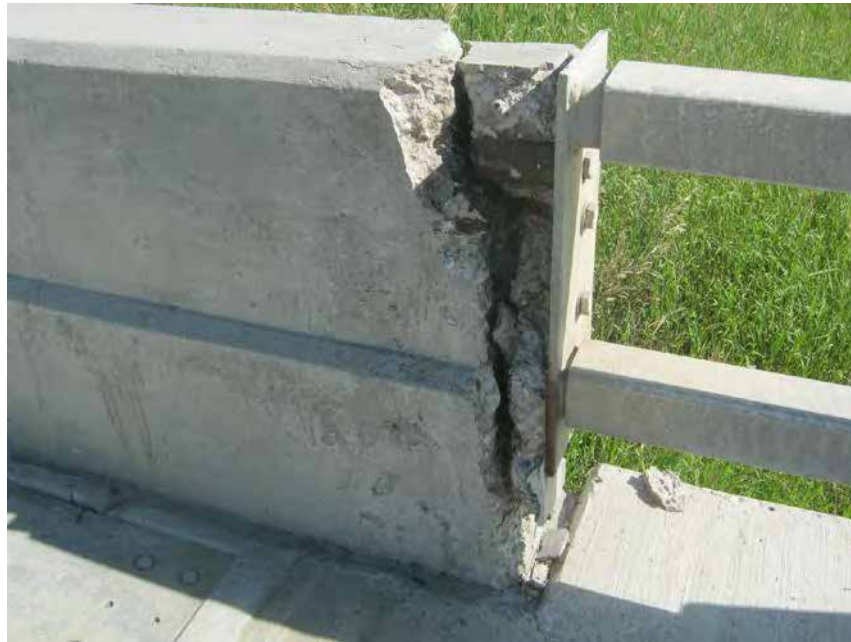
Curbs/Median	6	6	TRANSVERSE NARROW CRACKS @ 1m SPACING ✓		
(Curb Type: Standard) ✓					
Scaling (Percent Area)	1 ✓				
Bridge Rail	7	3	- N.W. RAIL BROKEN OUT @ PARAPET 21 A/B nuts not fully engaged ✓		
(Type: GALVANIZED STEEL BRIDGE TUBE) ✓					
Bridge Rail Posts	4	4			
(Type: GALVANIZED POST STEEL; GALVANIZED POST STEEL) ✓					
Bridge Rail/Posts Coating	5	5			
(Type: GALVANIZED) ✓					
Sidewalk	X	X			
Girders	5	5	Shear cracks @ piers abutment @ girders 0.35mm. @ West span & 0.77mm @ East span @ South fascia girder strengthened ✓ Vertical cracks 1mm wide @ girder @ piers ✓		
Diaphragms/Cross Frame	6	6	2 mm wide vertical cracks in several diaphragms. ✓		
Bearings	7	7	Roller brgs @ abuts ✓ Rockers on East & West pier. ✓ Pinned at center pier on a pedestal. ✓		
Temperature (deg. C)	+22 °C				
(Expansion Type: ROLLER BEARING; ROCKER BEARING) ✓					
(Fixed Type: PINNED BEARING)					
Coating Adequate (Y/N)	Yes ✓

Photo 9 Parapet broken at n.w.

Inspector Recommendations	Year	Inspector Comments	Department Comments	Target Year	Est. Cost	Cat #
REPAIR/REPLACE BRIDGE RAIL	2013	- REPAIR N.W. BRIDGE RAIL				
GALVANIZE/PAINT BRIDGE RAIL						
RETROFIT BRIDGE RAIL						
SEAL CURBS						
PATCH DECK	2014	PATCH CORE HOLE SPACES				
SEAL DECK	2014	✓ Chip coat deck for skid resistance				
OVERLAY DECK						
REPAIR/REPLACE DECK JOINTS						
RESET/PAINT BEARINGS						
WASHING						
SHOTCRETE REPAIRS						
REPAIR ABUTMENT SCOUR/EROSION						
PLACE ADDITIONAL RIP RAP	2014	- CONSIDER RIP RAP				
REMOVE DRIFT ACCUMULATION	2014	INSTALL ALL ALONG				
OTHER ACTION		WEST BANK BETWEEN				
OTHER ACTION		BOTH BRIDGES				
OTHER ACTION						
Structural Condition Rating (Last/Now)	66.7/	Sufficiency Rating (Last/Now)	59.9/	2025	✓	Maint. Req'd. (Y/N)
Special Comments for Next Inspection		Department Comments				Y
Maintenance Reviewed By		Date			Estimated Total	0
Proposed Long-Term Strategy

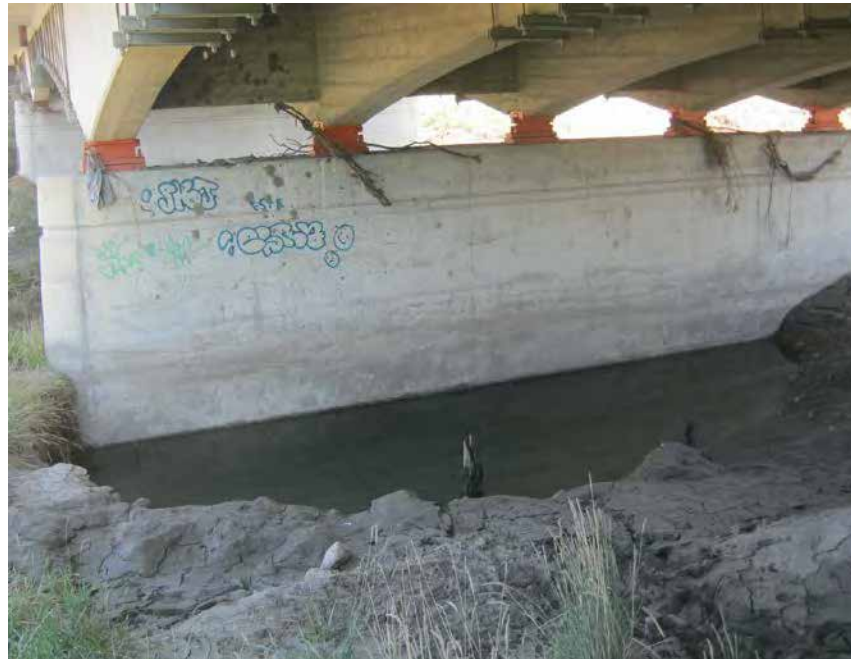
Scour	6	4	- SCOUR BEHIND P3	
Debris (Y/N)	Yes ✓		(Old piles under span 3) ✓ DRIFT @ PIERS	
Substructure General Rating	7	6		
Structure Usage				
	Last	Now	Explanation of Condition	
Channel				
(U/S Direction : S) ✓				
(D/S Direction : N) ✓				
Alignment	6	6		
Bank Stability	5	4	steep cut @ West + EAST - SCOURED @ N.W. SEATS 300mm HIGH	
HWM (m below Top of Curb)	1.5		No visible HWM - DRIFT ON PIER	
Drift (Y/N)	No ✓			
Slope Protection	5	4	- STEEP CUT @ WEST	
(Type : NATURAL; NATURAL)

Photo 10 Scour behind P3.

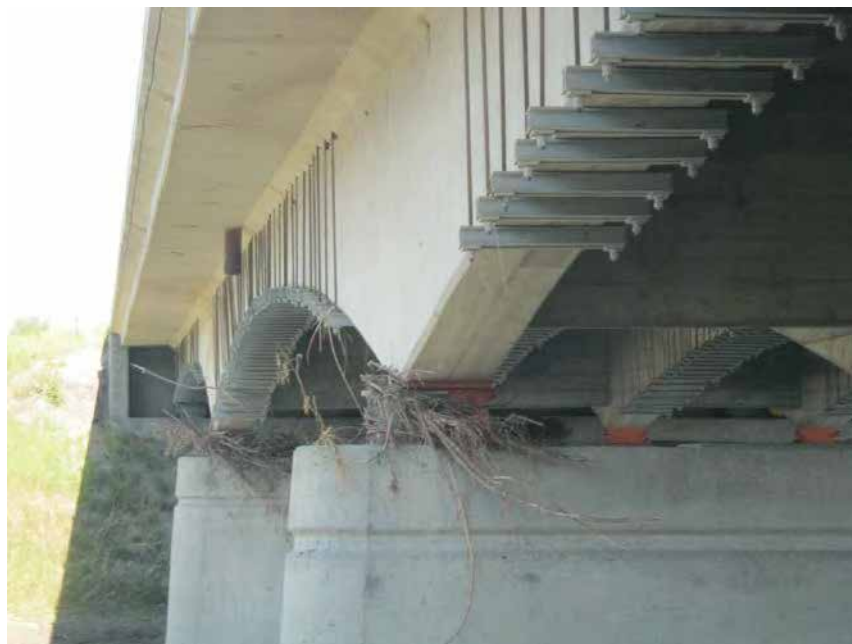
Photo 11 Looking west along south side- HWM drift on pier seat- 300mm high.

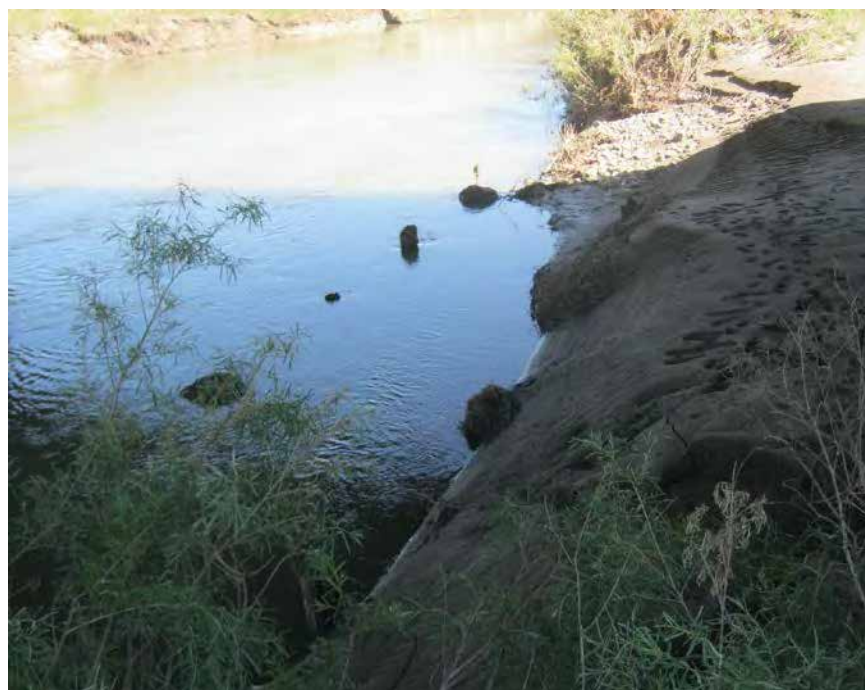
Photo 12 Minor scour at east bank under bridge.

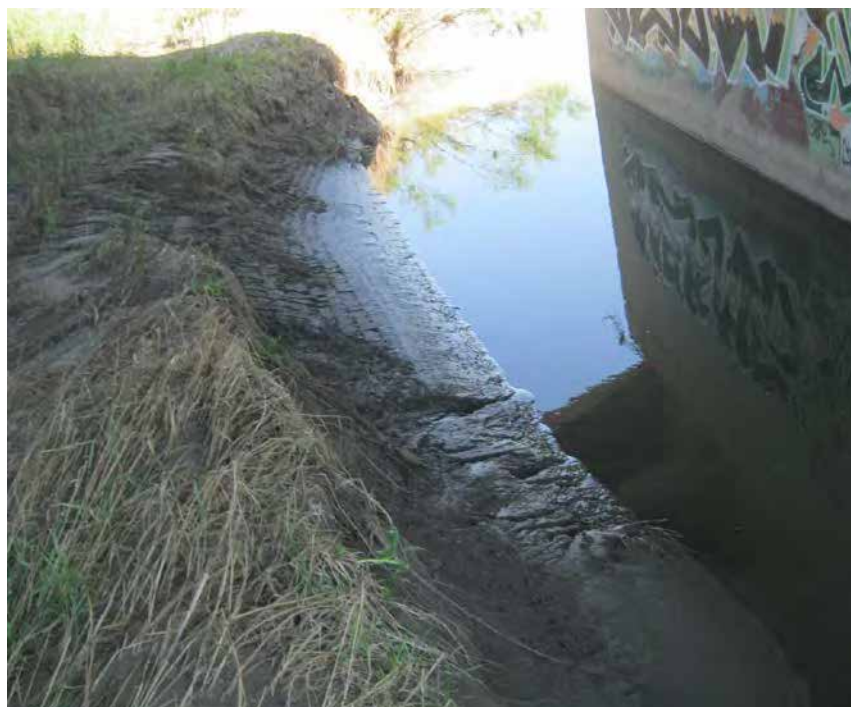
Photo 14 West bank cut under bridge at P1.

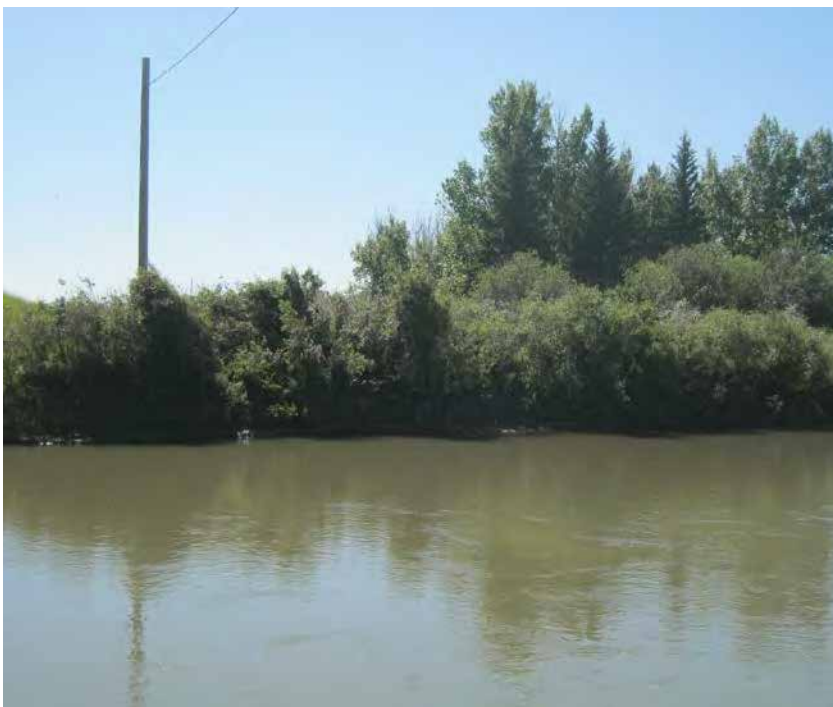
Photo 15 Cut bank at s.e.

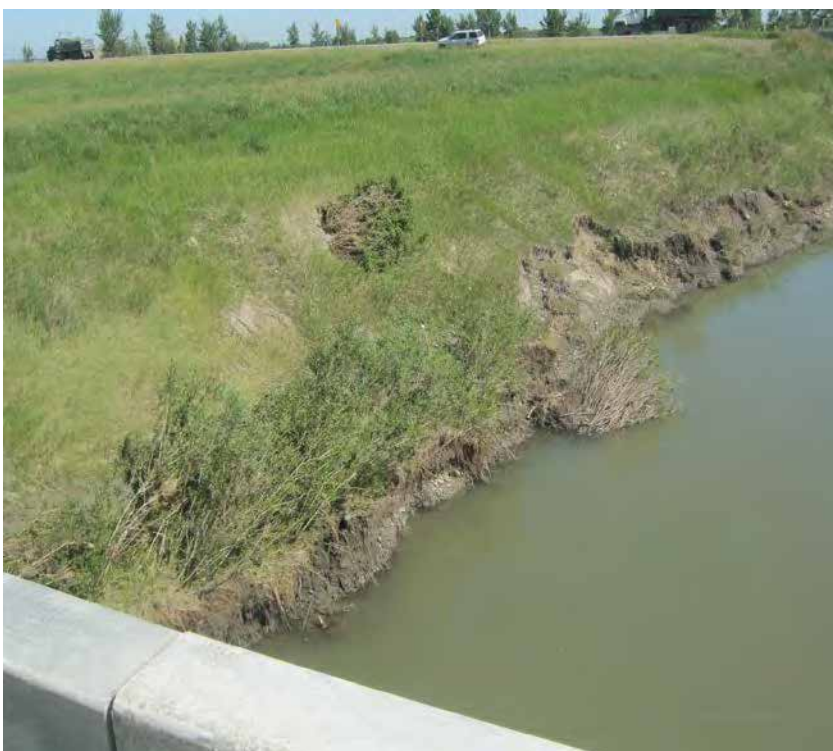
Photo 16 Scour at n.w. bank.

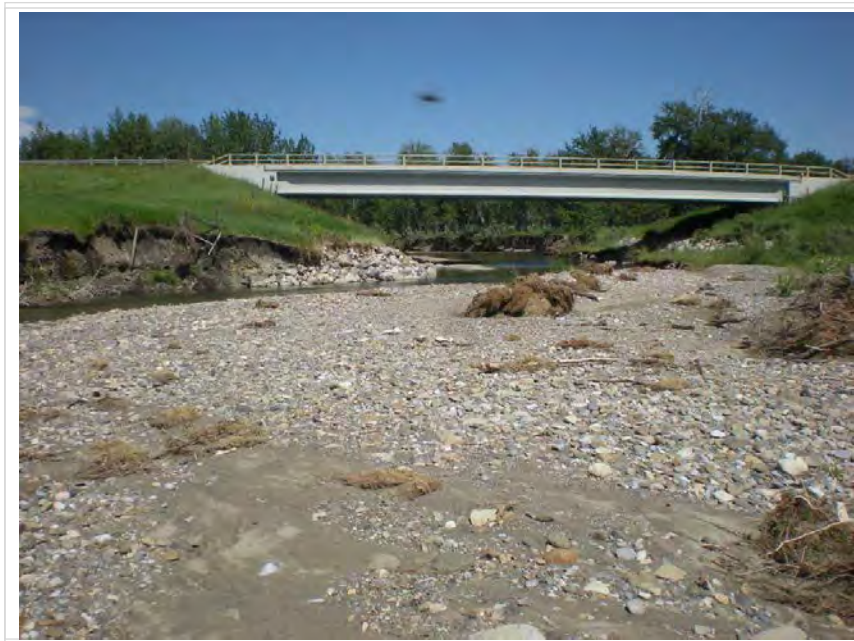
Channel Alignment	POOR U/S ALIGNMENT - RIVER ERODING N.W. CHANNEL EMBANKMENT - WELL AWAY FROM APPROACH ROAD EMBANKMENT
High Water Mark	5.5 m BELOW TOP OF CURB
Bank Stability	UNSTABLE BANKS U/S AT N.W. AND D/S AT S.E.
Drift/Debris	1% DRIFT AND DEBRIS CAUGHT IN U/S FENCING.
Slope Protection	PROTECT U/S CHANNEL BANKS WITH 20-30 m ³ /s CLASS 2 RIP RAP AT N.W.*
Guidebank/Spurs	RIP RAP GUIDE BANK AT N.W. RECOMMENDED.
Drainage	NO VISIBLE FLOOD DAMAGE.
Adequacy of Opening	OPENING APPEARS ADEQUATE.

Photo 5
Scour at NW embankment 30m upstream of bridge.

Other Item	
Other Item	
Other Item	
General Comment	OVERALL ASSESSMENT OF BRIDGE IS: 1) NO SIGNIFICANT FLOOD DAMAGE. 2) EXTEND CHANNEL ARMOUR 5-10m U/S AT N.W.
