Blackie Hall Report October 5, 2022

TOPIC: Blackie Community Hall Report

W. VAILE ENGINEERING AND DESIGN REPORT

Hazardous Building Materials Assessment

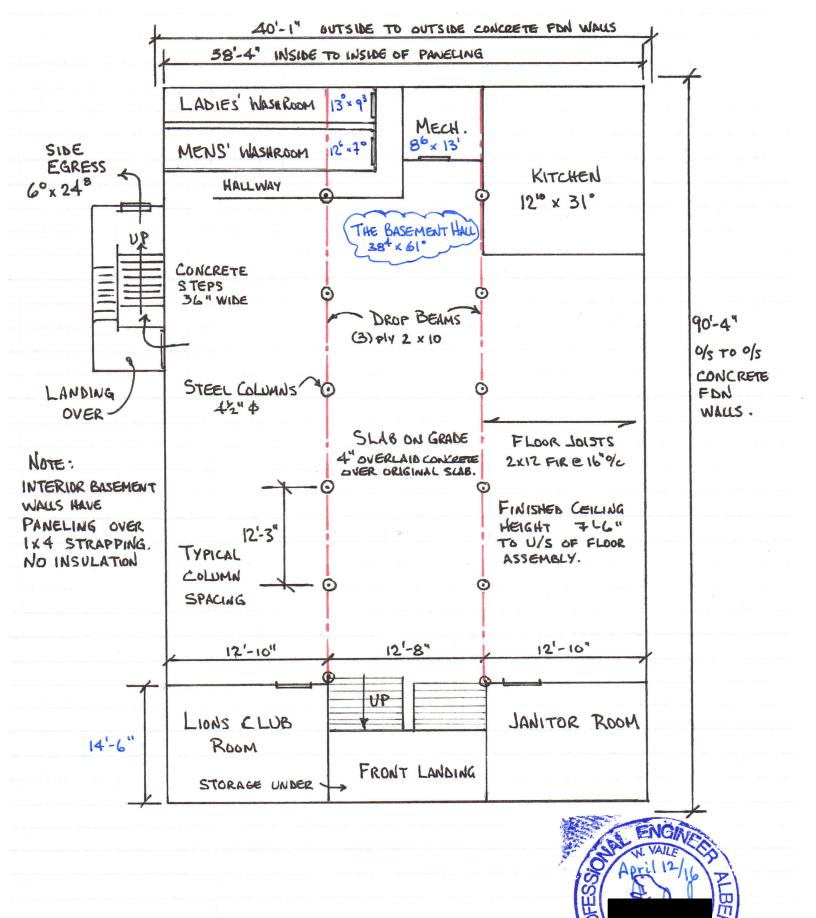
SK-3

BLACKIE COMMUNITY HALL BASEMENT FLOOR LAYOUT N.T.S.

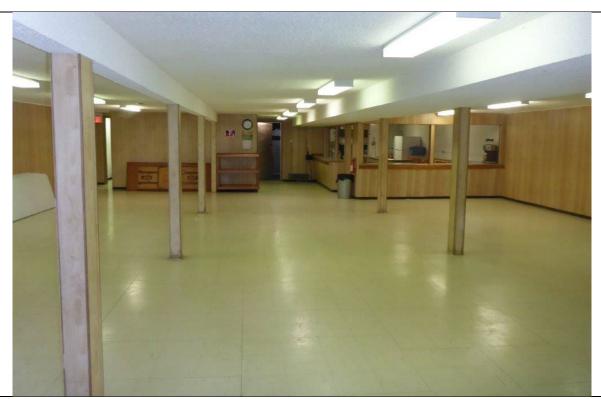
Photograph 4: View of entrance to basement level. Resilient floor tiles and lighting fixtures visible.

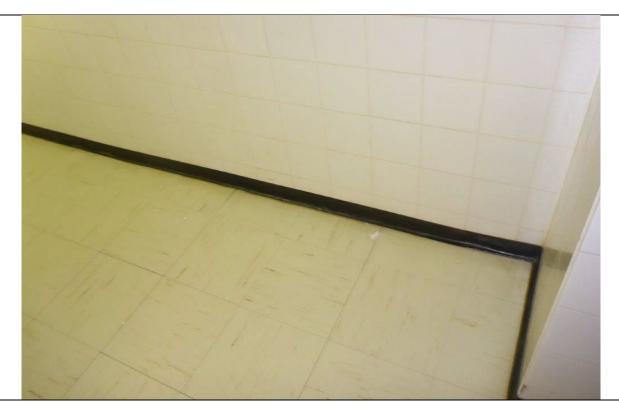
The flooring observed inside the basement of the building consisted primarily of RFT. All samples of these floor tiles were confirmed to contain 1 % chrysotile asbestos. The RFT throughout the basement in the building appeared to be in good condition, having a low potential for fibre release.

Photograph 5: Resilient floor tile within the women's washroom (basement).

The ACMs identified on the Site appeared to be in good condition. Therefore, there is no recommendation to remove the ACMS from the building. However, in the event of future renovations or demolition, ACMS identified by this investigation should be removed and disposed of by qualified trades prior to undertaking building renovation or demolition in accordance with Section 34 of the Alberta Occupational Health and Safety (OHS) Code, asbestos-containing building materials. The Alberta Asbestos Abatement Manual (current edition) defines an ACM as a product or building material containing asbestos in any quantity or percentage. Asbestos abatement procedures must follow applicable legislated standards or requirements and should be designed and supervised by a qualified professional. In the event that other suspect ACMs are encountered during demolition, confirmatory testing of the materials should be completed in order to determine appropriate handling and disposal requirements.

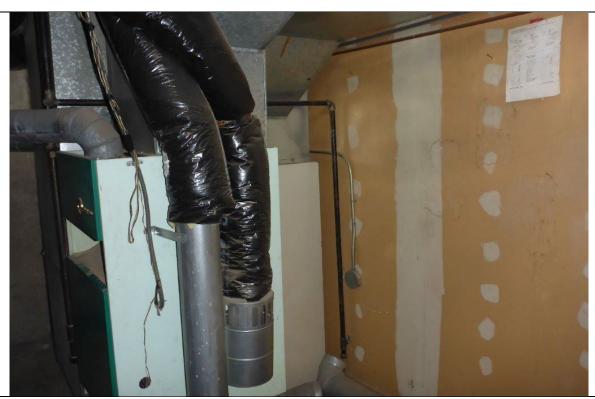
One sample of gypsum board joint compound was confirmed to contain 2% chrysotile asbestos. This sample was collected from the basement furnace room. The gypsum board throughout the basement generally appeared to be in good condition. Gypsum board located in the front main entrance hallway was observed during the assessment and can be assumed to contain asbestos. Gypsum board in the main hallway appeared to be in good condition. Accessibility to this material is considered moderate and is likely to be located in areas of moderate activity when the building is occupied.

Photograph 6: Gypsum board within furnace room (basement).

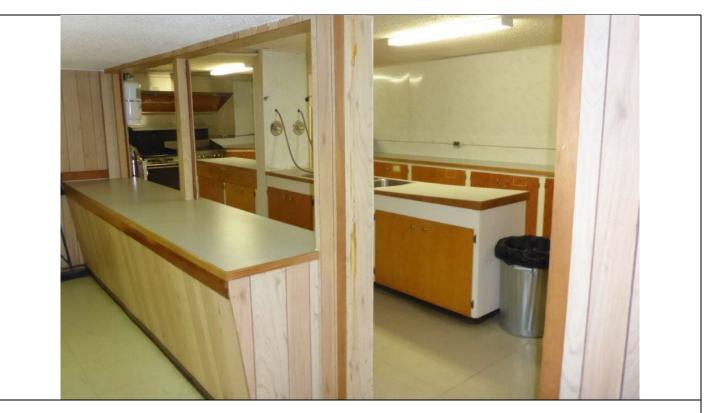
Two refrigerator units were observed on the Site, located in the main floor bar, and basement kitchen. Both units contained Freon R134 (1,1,1,2-tetrafluoroethane). One freezer unit was observed in the main floor bar area. This unit contains cyclopentane (C-pentane). A fire suppression system (Range Guard, Model RG-2-5G) was observed in the basement kitchen.

Photograph 7: The kitchen (basement). Fire suppression system located on wall near range hood.

All equipment confirmed or suspected of containing ODSs should be inspected by a licensed technician prior to removal or disposal. If found to contain ODS, any units taken out of service must be decommissioned in accordance with federal and provincial regulations.

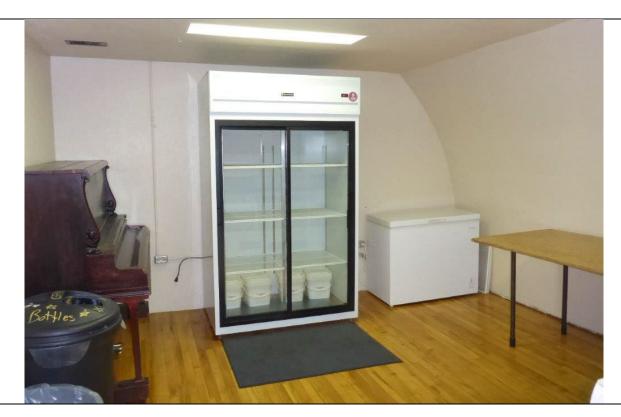
Photograph 9: Main floor bar room. Refrigeration and freezer unit.
