## Alberta Transportation

### Final Report

### Okotoks Interchange Operational and Safety Review

April 2022

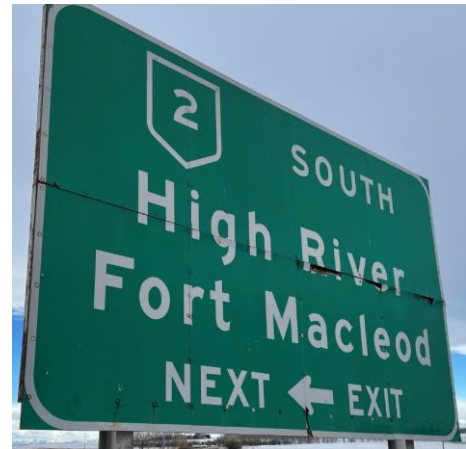
Damaged Guide Sign  
(Highway 2A:06, Westbound Km 5.841)

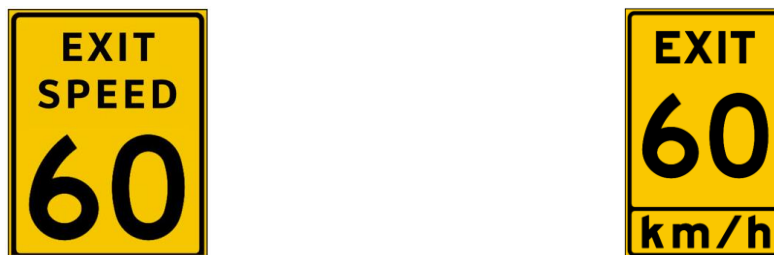
Figure 8.1: Existing sign (Left) vs. Current Standard (Right) for Ramp Advisory Speed Sign

The ramp advisory speed signage used at the intersection is an older sign type, which includes the words 'Exit Speed' and is different than the existing standard. This may not be a significant issue, but noted for information. Both are shown in the following figure.

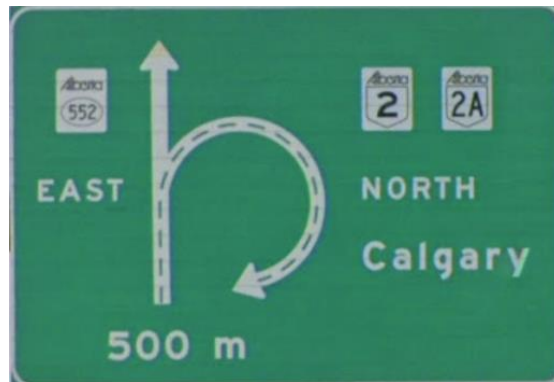
Highway 2A:06 (overhead sign)

- **Object marker signs:** Hazard markers are missing on HWY 2A:06 marking the median and in the westbound direction, at west ramp intersection.
- **Highway 2A:06 (Eastbound):** The overhead diagrammatic sign could be replaced with an updated diagrammatic sign showing only one lane continuous to the east. The thickness of the arrow implies that both lanes continue east. The existing sign is shown below.
