Post Flood Bridge Inspection Form

Bridge File Number	01741-1 ✓	Inspector Name	J. RUSSO
Location Description	HIGHWOOD RIVER BRIDGE ON HIGHWAY 22, 1 KM S OF LONGVIEW ✓	Assistant Name	
		Inspection Date	13-JULY-2013
Legal Land Location	NE SEC 17 TWP 18 RGE 2 W5M ✓		
Longitude; Latitude	-114.234062; 50.522899 ✓		
Unique Span Types	PO, CS ✓

File No.	01741
Date	July 13, 2013
Photos By	J. Rusu
Stream/Highway/Location	Highwood River / Hwy 22 / Longview

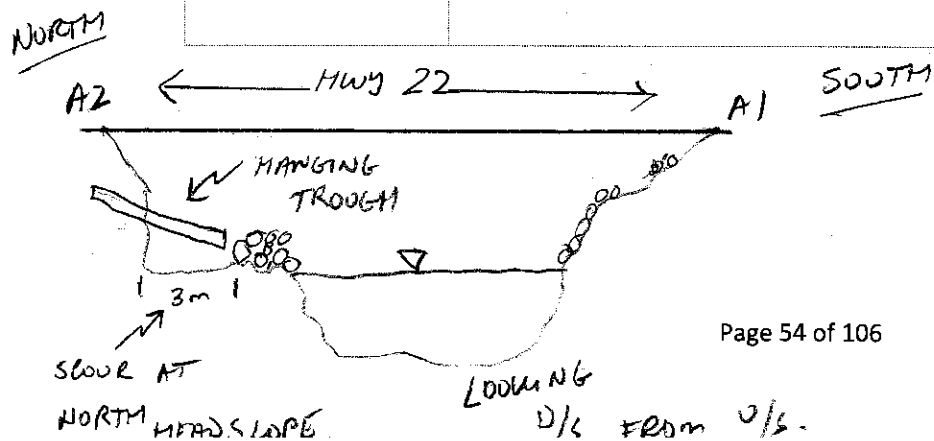
Channel Alignment	O.K. NO PROBLEMS OR VISIBLE FLOOD DAMAGE
High Water Mark	1.8m BELOW T.O.C. - GRASS CAUGHT ON S.W. FENCING AT U/S
Bank Stability	SOME EROSION @ U/S + D/S BANKS - STABLE
Drift/Debris	DRIFT LINE AND DEBRIS CAUGHT ON U/S FENCING
Slope Protection	ADD 50m ³ OF CLASS II RIP RAP TO NORTH HEADSLOPE & INCLUDE CATTLE TRACK TO ALLOW FOR CATTLEPASS
Guidebank/Spurs	NONE AT THIS BRIDGE.
Drainage	NO VISIBLE FLOOD DAMAGE.
Adequacy of Opening	ADEQUATE.

Other Item	
Other Item	
Other Item	
General Comment	EROSION REPAIRS AT DRAIN TROUGHS AND ADDITION OF SCOUR PROTECTION AT NORTH ABUTMENT HEADSLOPE RECOMMENDED.

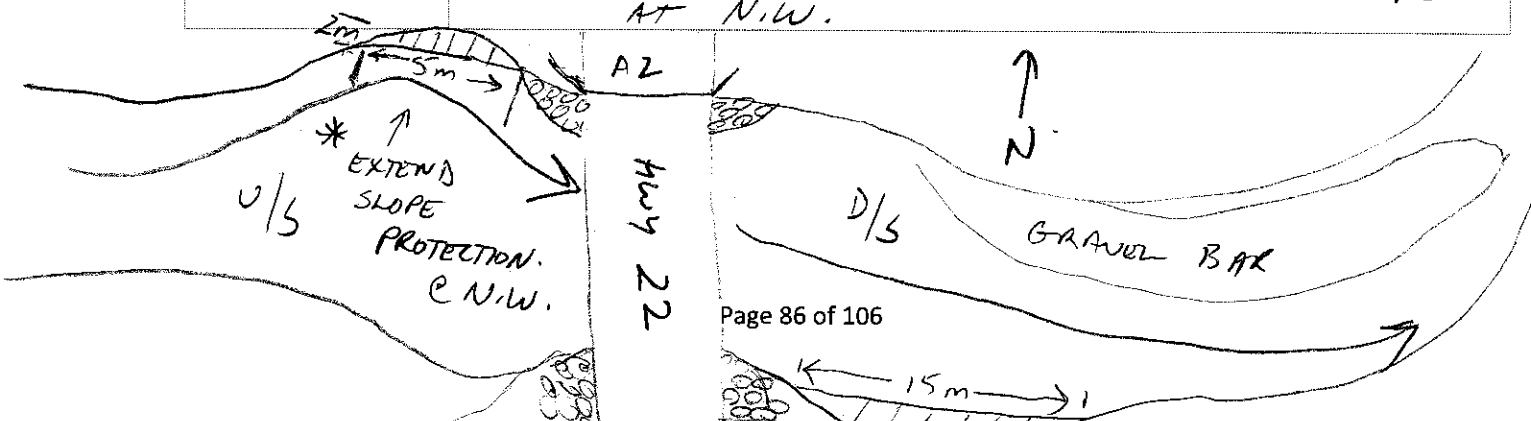
Channel Alignment	POOR U/S ALIGNMENT - RIVER ERODING N.W. CHANNEL EMBANKMENT - WELL AWAY FROM APPROACH ROAD EMBANKMENT
High Water Mark	5.5 m BELOW TOP OF CURB
Bank Stability	UNSTABLE BANKS U/S AT N.W. AND D/S AT S.E.
Drift/Debris	1% DRIFT AND DEBRIS CAUGHT IN U/S FENCING.
Slope Protection	PROTECT U/S CHANNEL BANKS WITH 20-30 m ³ /s CLASS 2 RIP RAP AT N.W.*
Guidebank/Spurs	RIP RAP GUIDE BANK AT N.W. RECOMMENDED.
Drainage	NO VISIBLE FLOOD DAMAGE.
Adequacy of Opening	OPENING APPEARS ADEQUATE.

Other Item	
Other Item	
Other Item	
General Comment	OVERALL ASSESSMENT OF BRIDGE IS: 1) NO SIGNIFICANT FLOOD DAMAGE. 2) EXTEND CHANNEL ARMOUR 5-10m U/S AT N.W.
