## Alberta Transportation

### Final Report

### Okotoks Interchange Operational and Safety Review

April 2022

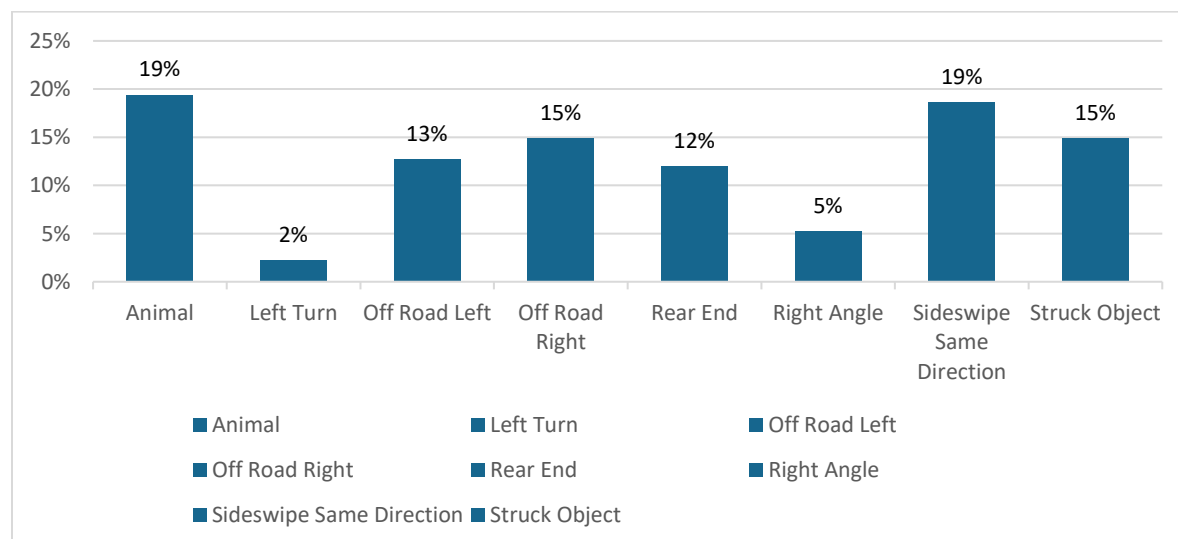
Figure 4.1: Distribution of Collisions by Type

The spread of the four (4) most dominant collision types is close (<4% difference between each type) and are the animal, sideswipe same direction, off road right, and struck object types. Left turn and right angle were the least frequent collision types, making up 2% and 5% of collisions, respectively.

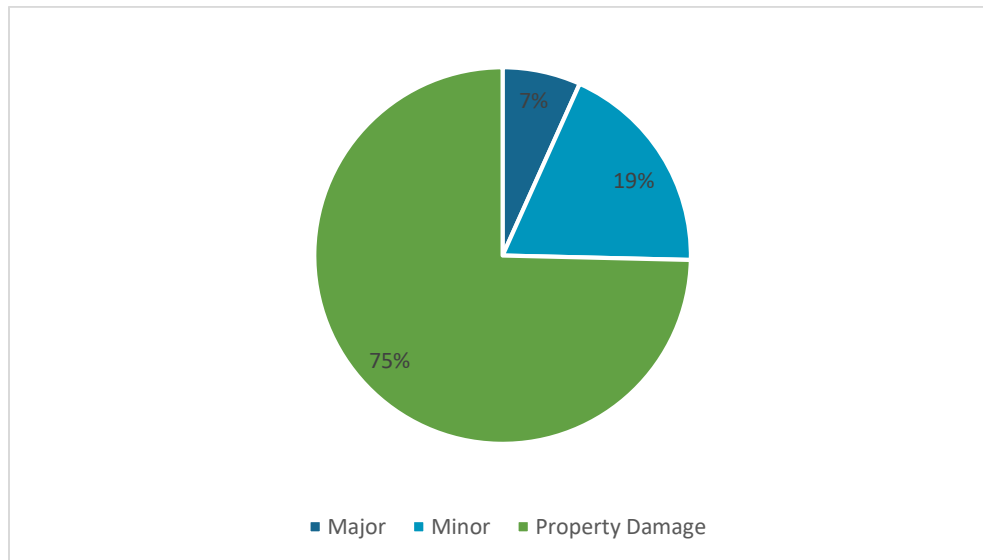
Figure 4.2: Distribution of Collisions by Severity

Figure 4.2 shows the collision severities by percentage of total collisions. Most collisions resulted in property damage (100). There was a total of 25 minor injury collisions and nine (9) major injury collisions. Over the six (6) year assessment period there were no fatal collisions.

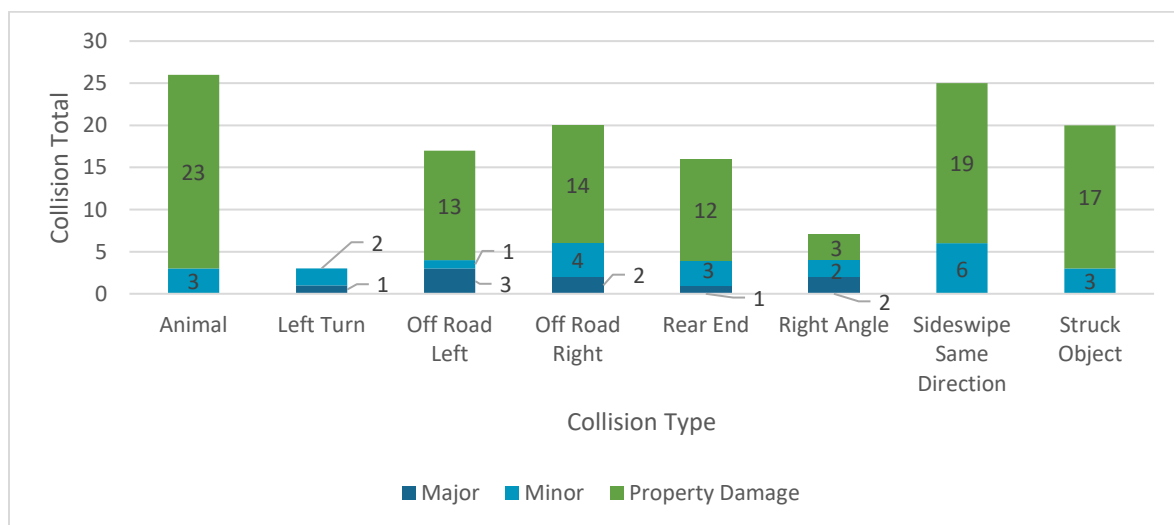
Figure 4.3: Distribution of Collisions by Type and Severity

Figure 4.3 provides a summary of the collisions by type and severity. Only off road left, off road right, rear end, and right angle collision types resulted in major collisions over the six (6) year period.

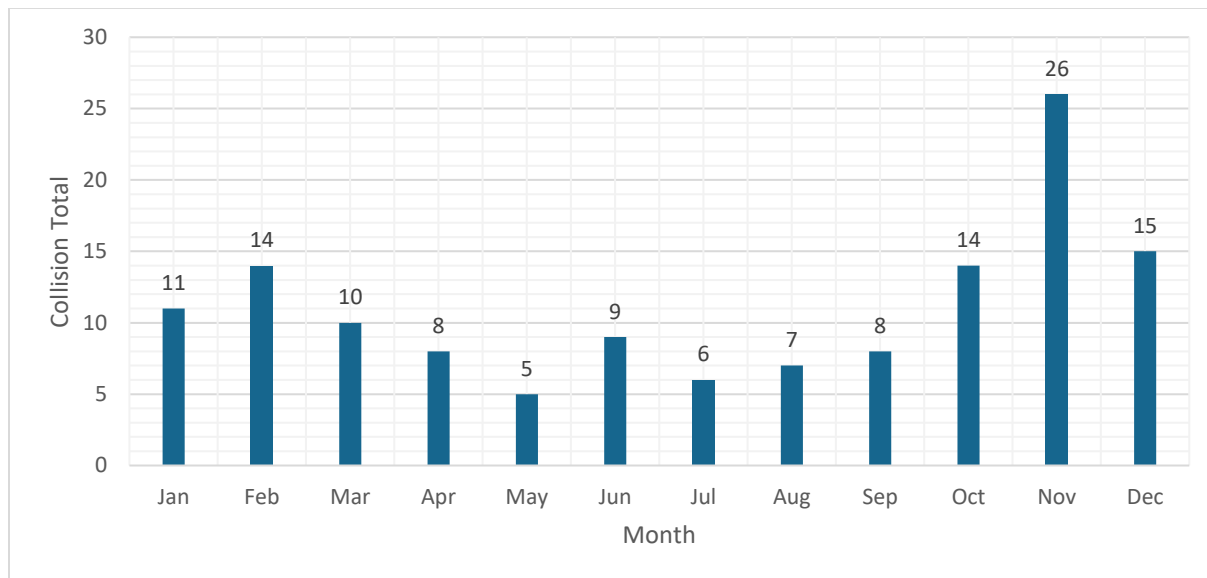
Figure 4.5: Distribution of Collisions by Month

Figure 4.5 indicates the number of collisions per month. Collision totals trend upward during winter months, indicating that environmental and surface conditions may be a contributing factor. The data illustrates a total of 90 collisions from October and March compared with 43 from April to September.

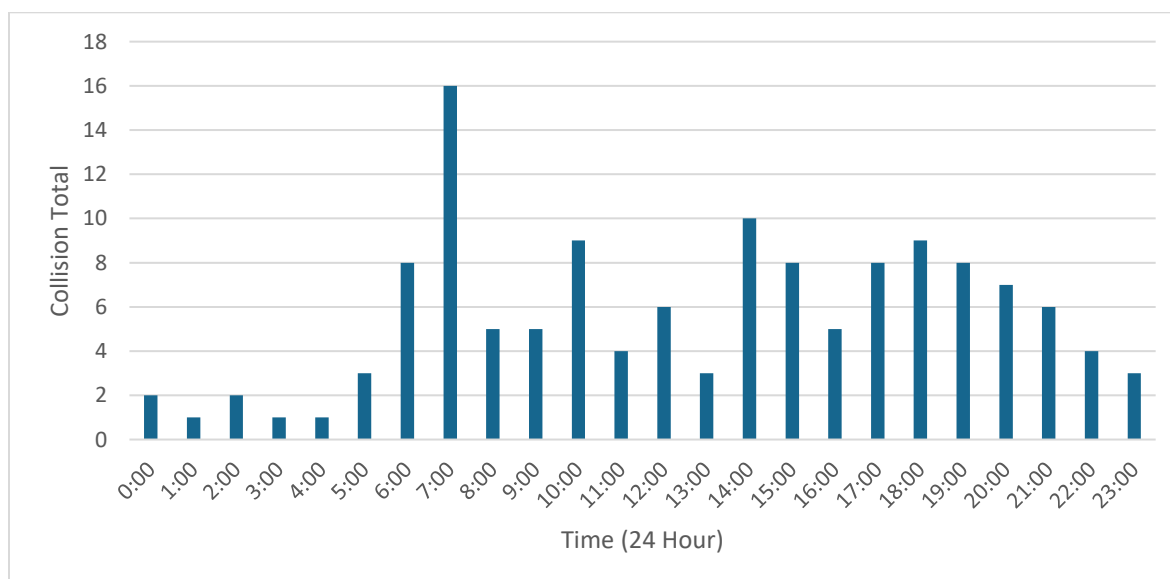
Figure 4.6: Distribution of Collisions by Time of Day

Figure 4.6 shows the distribution of collisions throughout the day in one-hour groupings. The collision distribution has one (1) large peak and two (2) smaller peaks. The large peak is in the period from 7:00 to 8:00 a.m. The smaller peaks are in the 2:00 to 3:00 p.m. hour and the 5:00 to 6:00 p.m. hour. Collisions peaks correlate well with peak traffic periods.

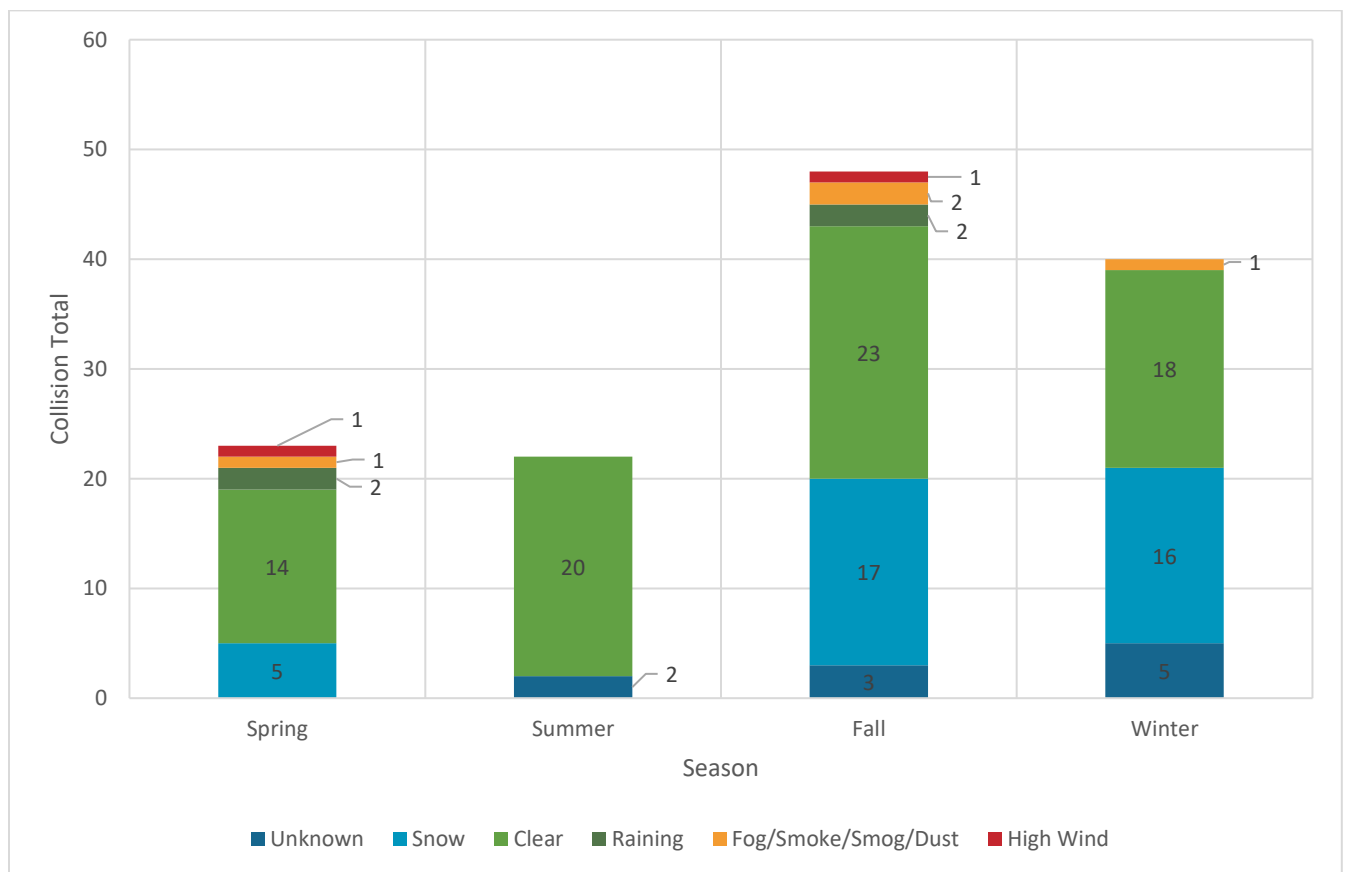
Figure 4.7: Distribution of Collisions by Season and Environmental Condition

Figure 4.7 shows the distribution of collisions by season and environmental condition. Seasons are defined as a three-month period from the first day to the last day of each month for Spring (March, April, May), Summer (June, July, August), Fall (September, October, November) and Winter (December, January, February). Most collisions occurred in Fall (48) and Winter (40), and the fewest in Summer (22) and Spring (23).

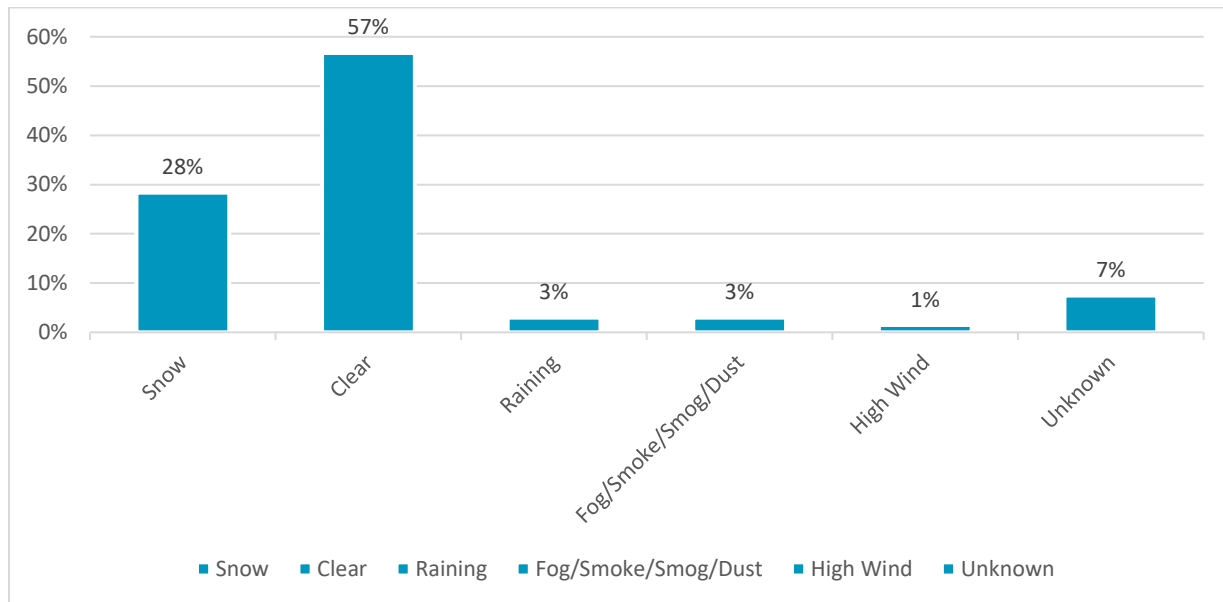
Figure 4.8: Distribution of Collisions by Environmental Condition

The following section discusses other collision factors to be considered, including environmental conditions, surface conditions and lighting conditions. The percentage of total collisions by environmental condition is shown in Figure 4.8. From Figure 4.8, over half (57%) of total collisions occurred in clear weather conditions and 28% occurred in snowy weather conditions.

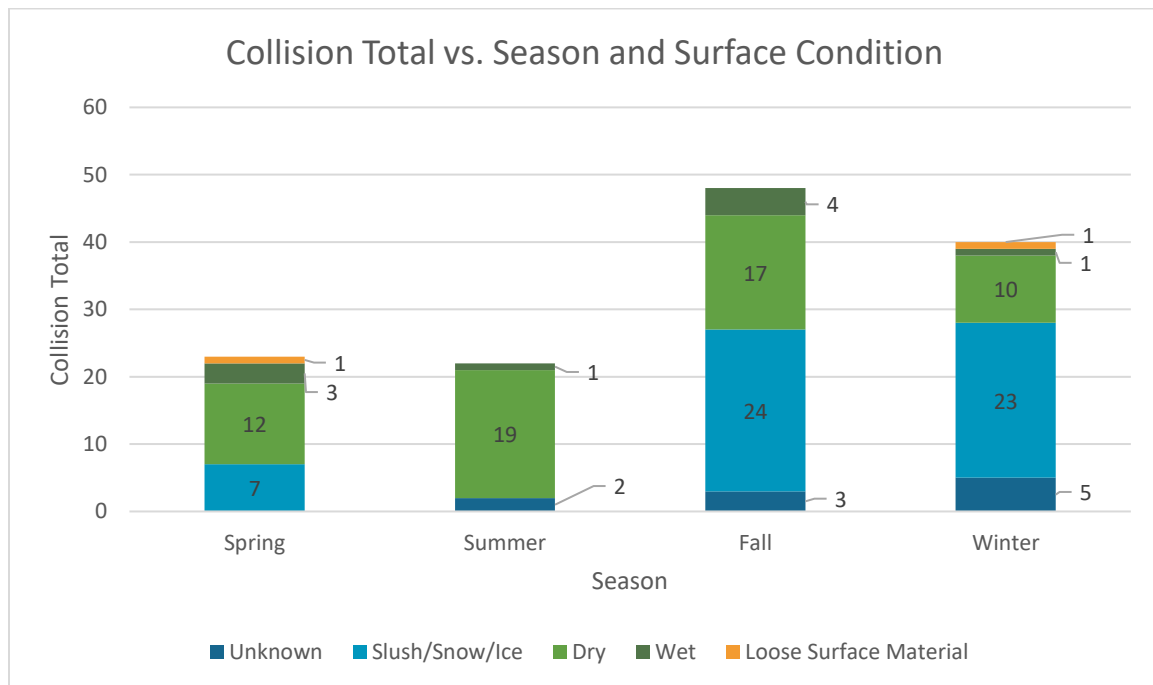
Figure 4.9: Spatial Distribution of Collisions by Season and Surface Condition

- Most collisions in the Fall and Winter occurred with slush/snow/ice on the road surface and most collisions in the Spring and Summer occurred with dry surface conditions.
- The number of collisions with dry conditions is relatively similar for all seasons, ranging from a low of ten (10) in the winter, to a high of nineteen (19) in the summer.
- The number of collisions with slush/snow/ice conditions is significant in the fall and winter, totaling 47, compared to seven (7) in the spring and summer months.

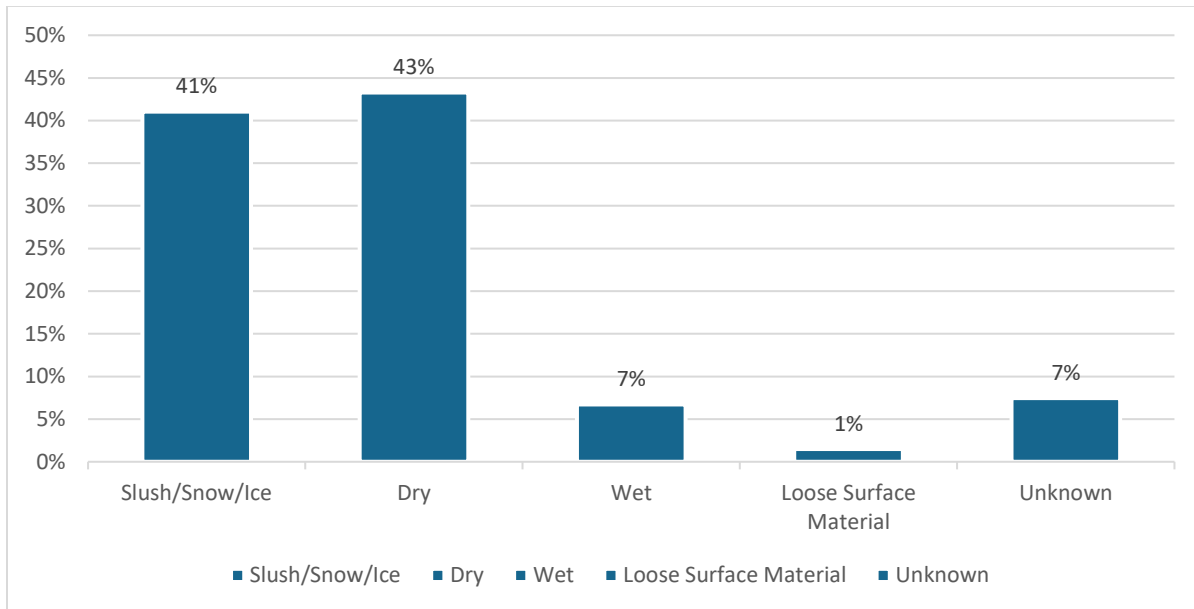
Figure 4.10: Distribution of Collisions Surface Condition

As shown in Figure 4.10, the total number of collisions that occurred in slush/snow/ice and dry conditions is comparable. This indicates that while slush/snow/ice would be a contributing factor to collisions, other surface conditions do not appear to play a significant role in causing collisions.

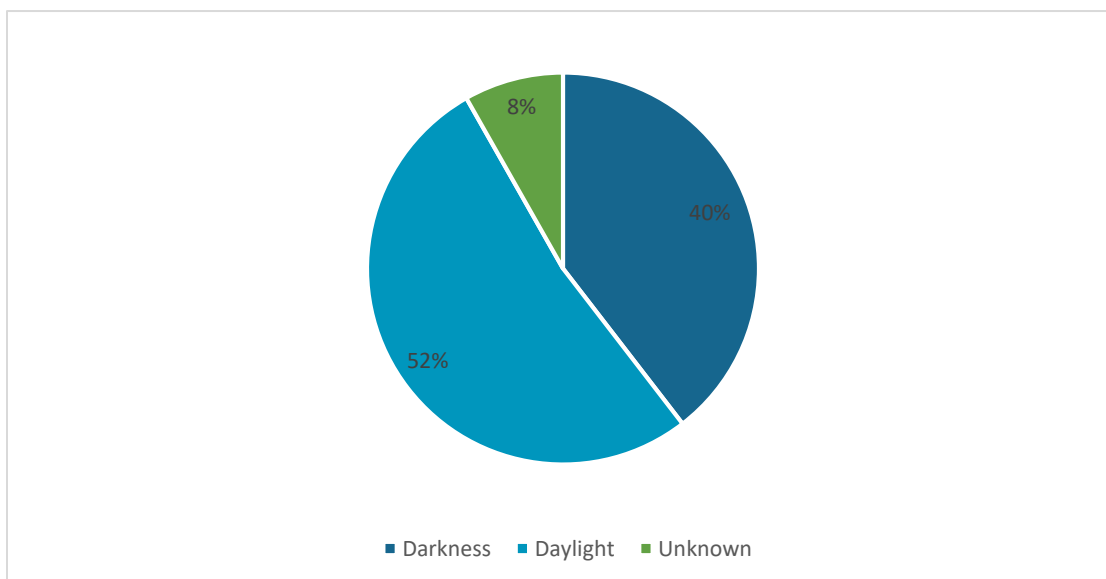
Figure 4.11: Distribution of Collisions by Light Condition

Figure 4.11 shows the distribution of total collisions by light condition. The majority of collisions occurred in daylight. However, a large proportion (40%) of collisions occurred in the darkness, indicating that visibility due to light conditions may be a contributing to a pattern of collisions in the study area. Peak traffic periods would notably occur in darkness during periods of shortest daylight in the winter months.

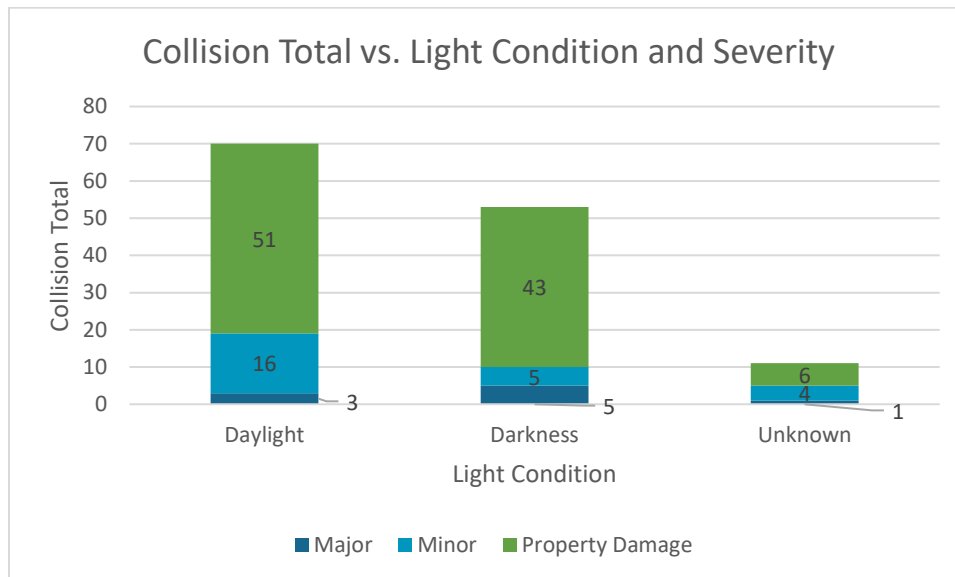
Figure 4.12: Spatial Distribution of Collisions by Severity and Light Condition

Figure 4.12 compares collision totals based on light condition and severity. Comparable collision totals can be observed in daylight, darkness, and unknown light conditions for minor collisions. However, almost twice as many major collisions occurred in darkness compared to daylight. Overall, the majority of collisions resulted in property damage only.

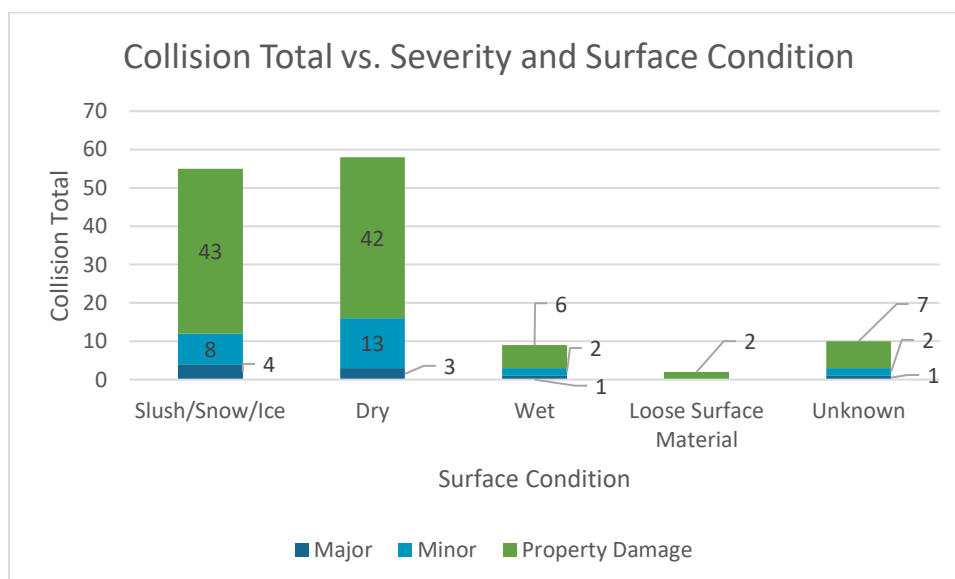
Figure 4.13: Spatial Distribution of Collisions by Severity and Surface Condition

Figure 4.13 compares collision totals based on surface condition and severity. The majority of collisions of all severities occurred in either slush/snow/ice or dry surface conditions, with comparable numbers across severities.

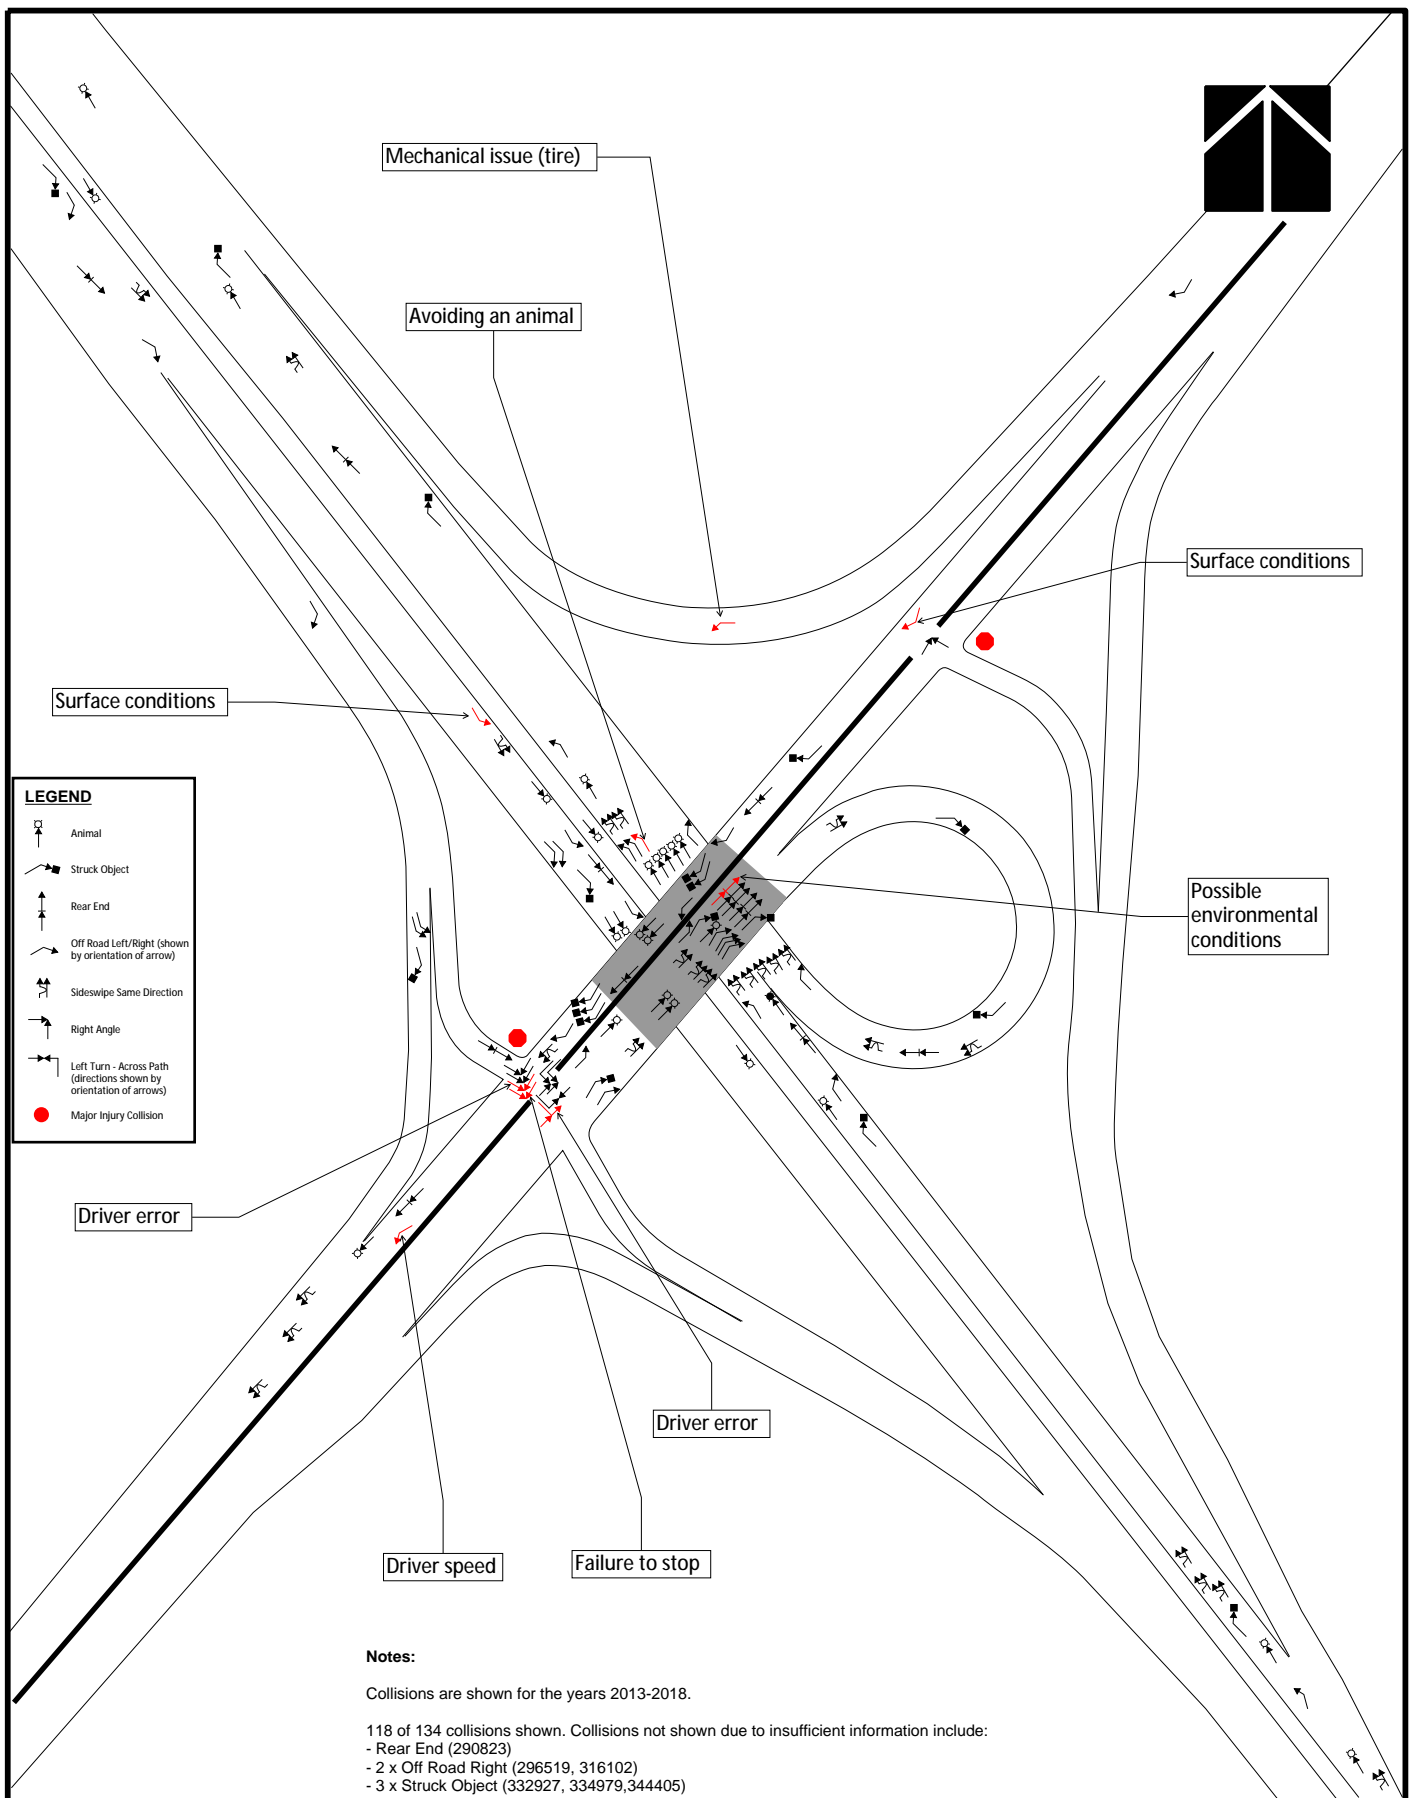
Generally, a significant number of collisions are centralized around the overpass, west ramp intersection and Highway 552:02 eastbound to northbound dual ramp merge area. The following discusses collision based on these locations within the study interchange area. Location and collision types are illustrated in Exhibit 4.1.

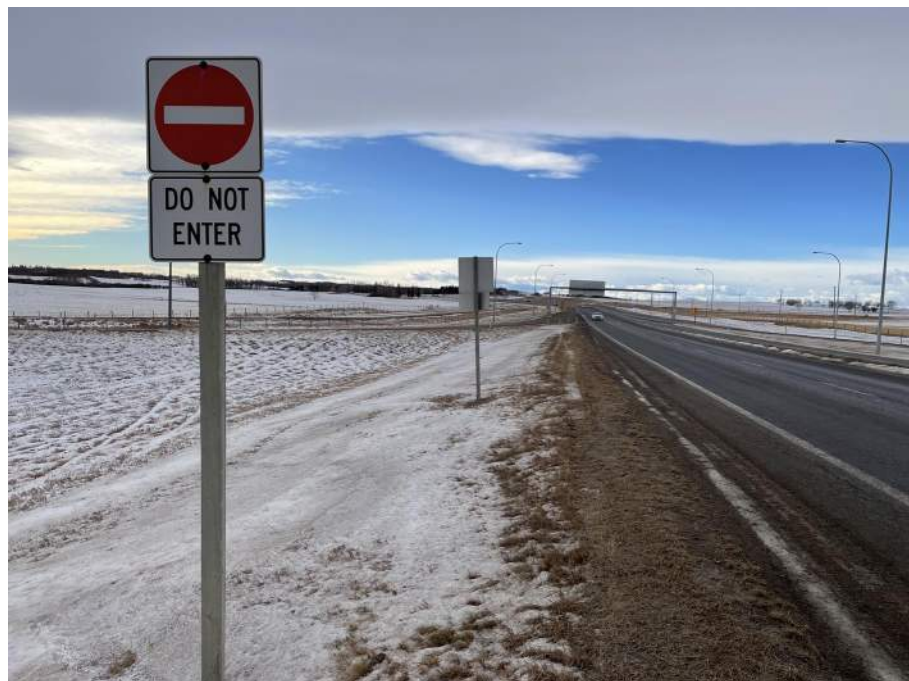
Photo 40: Highway 2A looking west, east of entrance Highway 2A:06 EBR ramp

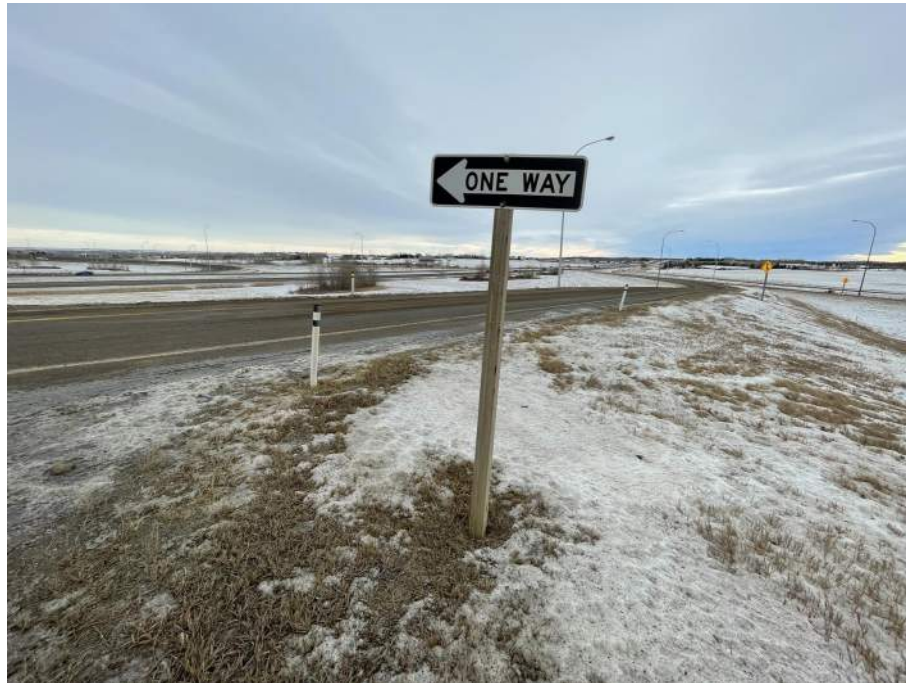
Photo 41: Highway 2:12, 2:15 bypass, looking south

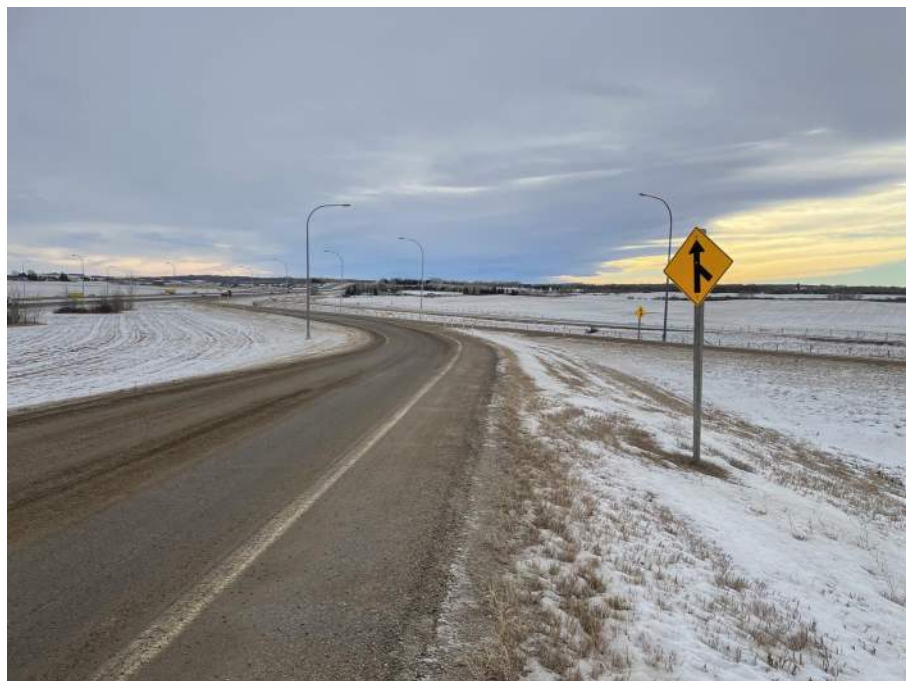
Photo 42: Highway 2:12, 2:15 bypass, looking south

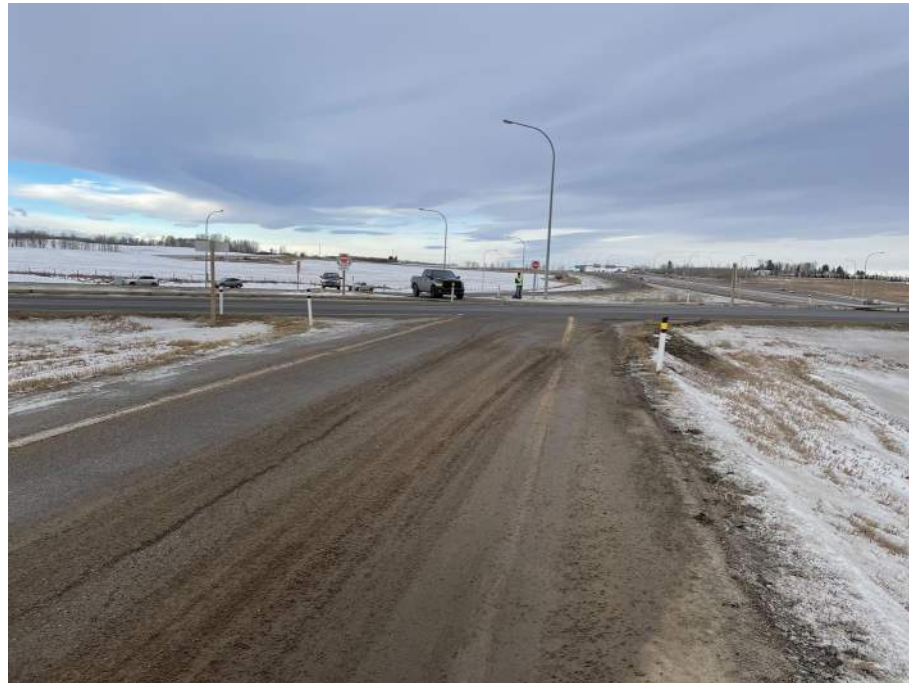
Photo 43: Highway 2:12, 2:15 bypass, looking north

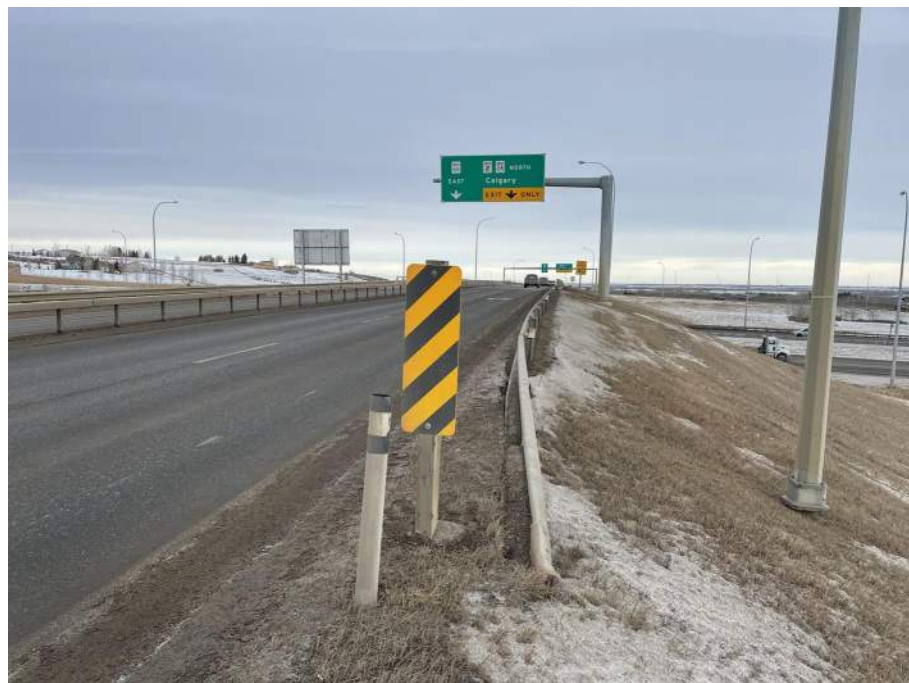
Photo 44: Highway 2A looking east at bridge

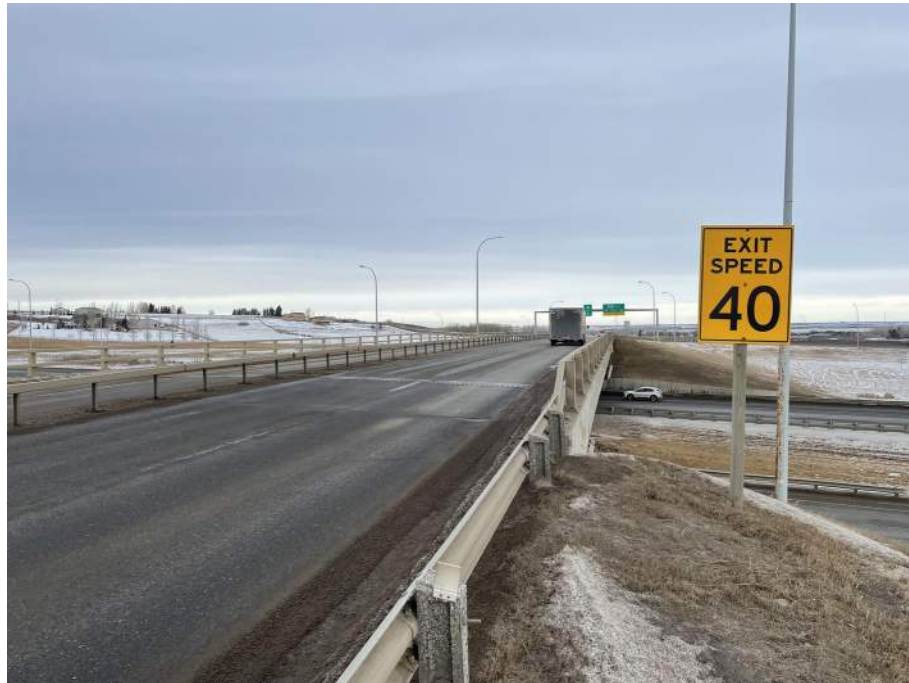
Photo 45: Highway 2A looking east at bridge

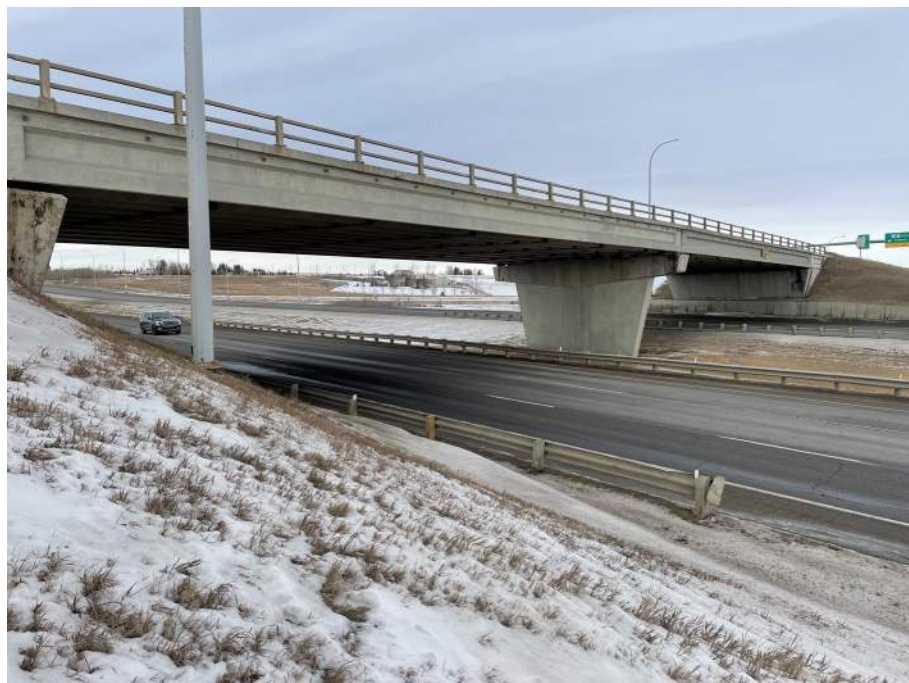
Photo 46: Looking northeast at overpass

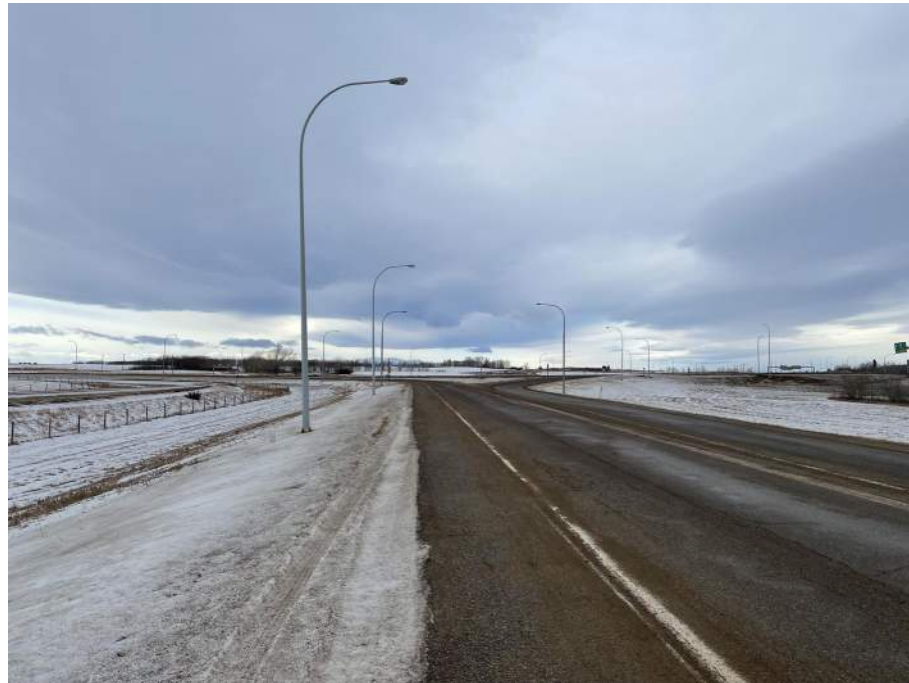
Photo 47: Highway 2A:06 EBR ramp, south of the overpass, looking north

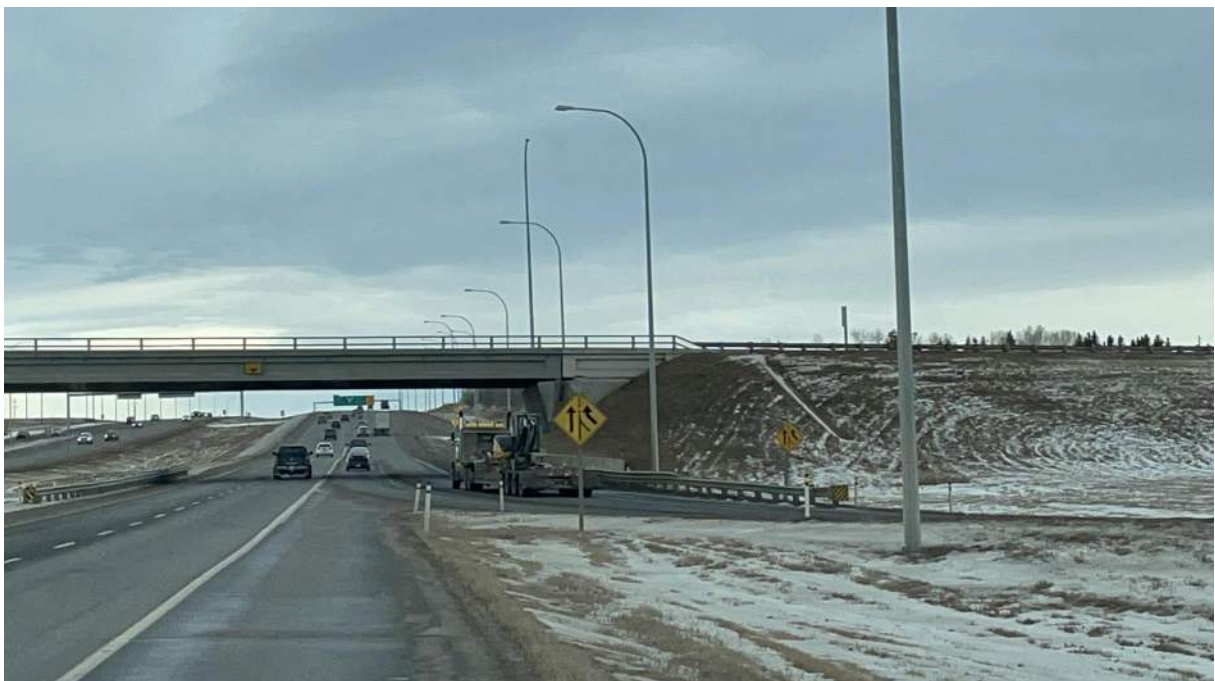
Photo 48: Looking north at the overpass from Highway 2
