# SCOPING STUDY OF FLOOD RELATED AREAS OF CONCERN ON THE HIGHWOOD RIVER WITHIN THE MD OF FOOTHILLS AND THE LITTLE BOW RIVER UPSTREAM OF THE TWIN VALLEY RESERVOIR

Municipal District of Foothills No. 31 High River, Alberta

Amec Foster Wheeler Environment & Infrastructure and Advisian
Calgary, Alberta

March 2017

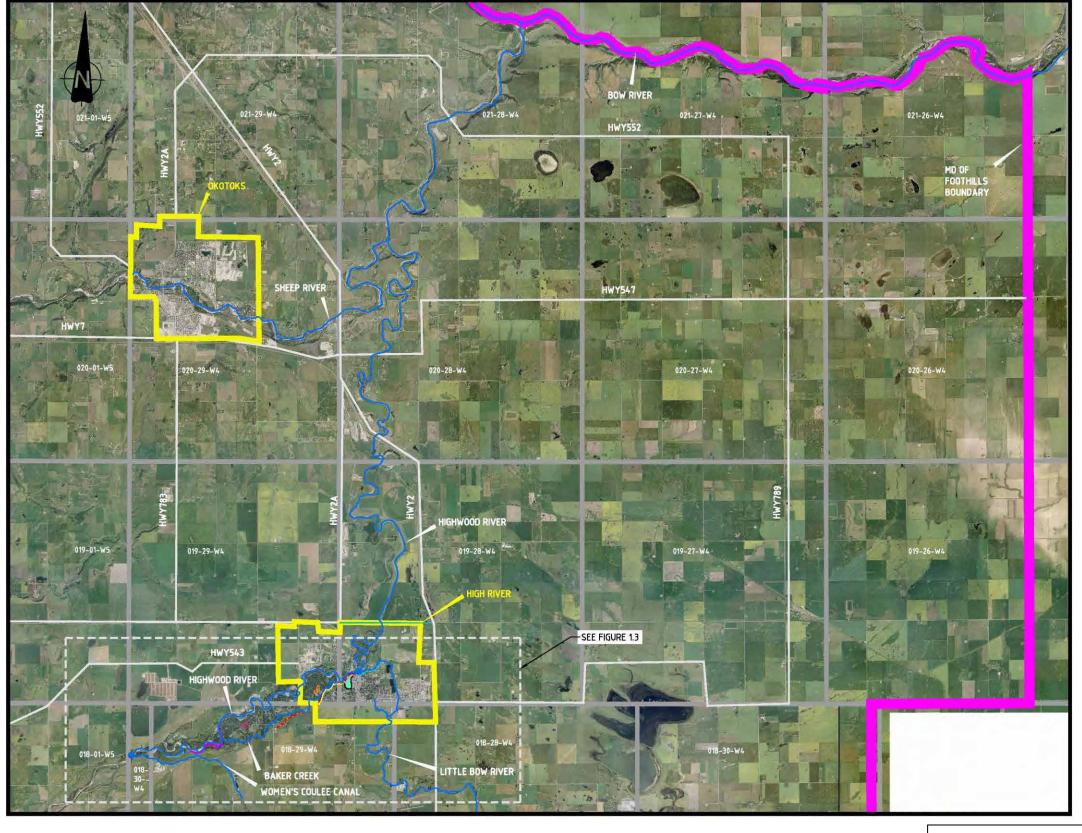
Figure No: 1.2 Rev: 2

# DATA SOURCE: 1. M.D. BOUNDARY REFERENCE FROM M.D. OF FOOTHILLS NO. 31, LAND USE MAP 2. IMAGE SOURCE: TOWN OF HIGH RIVER 2005 LEGEND: WATERCOURSE/CANAL LITTLE BOW-HIGHWOOD WATER SHED DIVIDE WEST TOWN DIKE TOWN DIKE BAKER CREEK DIKE HOEH DIKE BEACHWOOD DIKE BEWS DIKE INTAKE 10 01 2000 4000 6000 8000

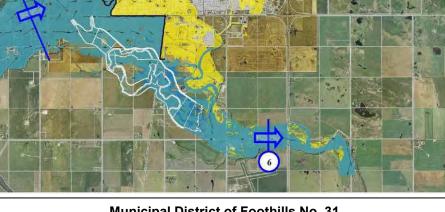
Date: Apr 28, 2017 | File Path: U:\CAL\GBS\307074- | Figure No. 2.1 | Rev. 1

Predicted Peak Flow (m³/s)			# 1		176.0	
Location		2013 Landscape Scenario	28A				r anah	3
	Upstream of Town	1820	1820	Ø	P	4	West.	
	Upstream of 498 Ave (Highwood River)	1225	1405	180		E		
	Upstream of HWY2 (Highwood River)	955	1245	290		12/10		
ļ	To 498 Ave (North of 498 Ave)	200	155	-45				
	To Hampton Hills (South of 489AVE)	200	0	-200				
	Upstream HWY2 (Little Bow River)	560	410	-150		100		No.
	<ul> <li>Predicted June 2013 Flood Extents for Existing</li> <li>Predicted June 2013 Flood Extents for Post-Mit</li> </ul>	ACTOR AND ADDRESS						T.
-	国际 1 1 1 1 1 1 1 1 1 1 1 1 1 1 1 1 1 1 1							2
			W/25	The second secon		1 A	. 1 Page 1	
					1

# Highwood River - Little Bow River Estimated Flow Split Scenarios

Preliminary estimates of the effect of the two flow additions described above indicate an increase of approximately 180 m³/s (from 1,225 to 1,405 m³/s), in the Highwood River just downstream of the Town, considering the 2013 flood magnitude of 1,820 m³/s above Women's Coulee Canal inlet (**Figure 2.1**). Conversely, the Little Bow River is expected to experience a decrease in peak flow from approximately 560 m³/s to 410 m³/s under conditions similar to the 2013 flood (**Figure 2.1**). The increase in flood flow magnitude on the Highwood River at the Highway 2 Bridge north of the Town is even greater due to the raising of 498 Avenue E, and loss of floodplain storage associated with the Hamptons area located within the Town. This effect is discussed further in **Section 2.2.2**.

The change in the flow-split between the Highwood-Little Bow rivers due to diking and the increase of flows north (downstream) of 498 Avenue E due to raising of this road (resulting in loss of floodplain storage) have significantly altered the flood peak magnitudes downstream of 498 Avenue E for low probability, infrequent flood events. The raising of 498 Avenue E was undertaken to protect the east side of the Town, including the Hampton Hills, Sunshine, and Sunrise neighbourhoods. Peak flow magnitude at the Highway 2 bridge is estimated to be approximately 290 m³/s greater than 2013 Flood Landscape Scenario (which is synonymous with the existing condition at the time of the 2013 flood or the condition pre-2013/2014 flood mitigation works), increasing from 955 m³/s to 1,245 m³/s (**Figure 2.1**). Additional information pertaining to the 2013 Landscape Scenario is provided in **Section 3.0**.

However, as flows increase above 1,000 m³/s, the change in flood risk level becomes apparent. Change in flood risk in terms of flood magnitude for the 1,820 m³/s 2013 flood peak estimate are provided in **Figure 2.1**. The change in flood risk (in terms of flow magnitude), based on preliminary modelling results, between the 2013 Landscape Scenario and the complete mitigation scenario (Scenario 28A) in terms of various flow magnitudes (i.e. 750, 940, and 1,380 m³/s above Women's Coulee Canal Inlet) is illustrated in **Figure 2.4** for the Highway 2 and 498 Avenue E bridge crossing locations. **Figure 4** indicates that the peak flow changes begin to increase between the 2013 Landscape Scenario and the complete mitigation scenario (Scenario 28A) for peak flows greater than approximately 1,000 m³/s (above Women's Coulee Canal Inlet). Note that inflow hydrographs for each peak flow magnitude were estimated using available information and that these results are preliminary. That is, these results may change with time as the model is updated and refined as information becomes available and model development progresses. The 2013 Landscape Scenario and complete mitigation scenario (Scenario 28A) are discussed further in **Section 3.0**.

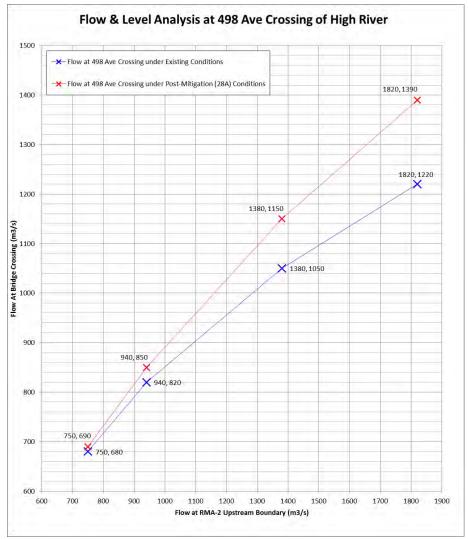
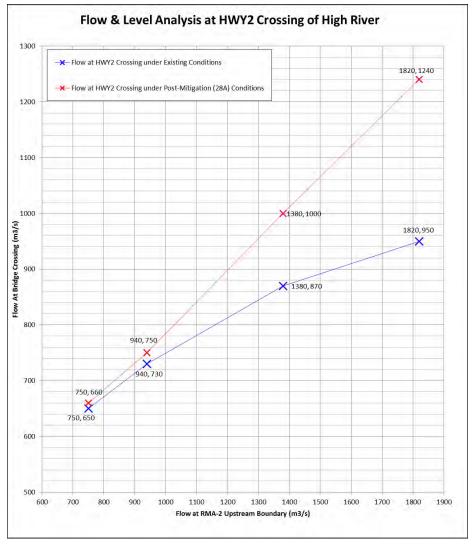
Figure No: 2.4

Flow Relationship; Highwood River above Women's Coulee Inlet vs Highwood River At Crossing Downstream of Town of High River

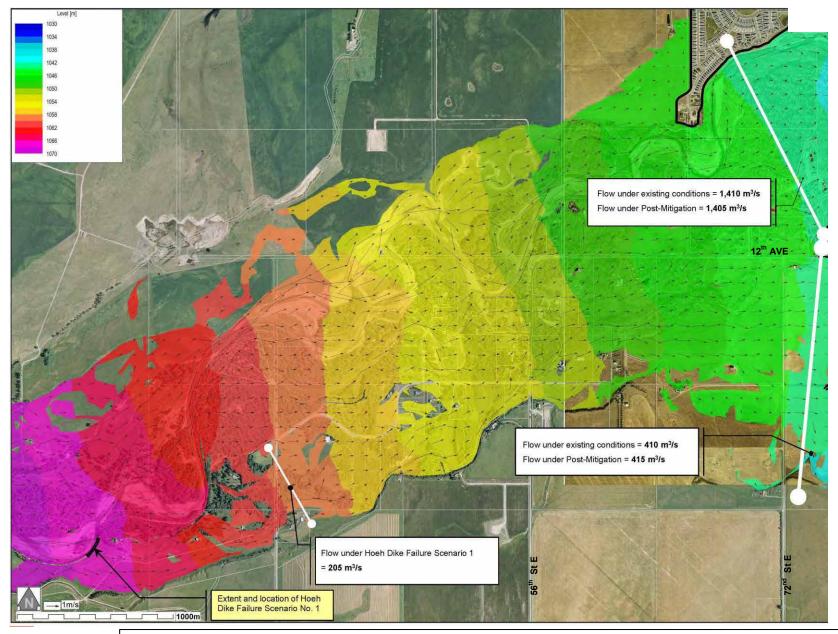
Figure No: 4.2.1

Hoeh Dike Failure Scenario 1 (150 m breach of upstream segment) - Peak Flow Summary (Scenario 28A) - 1,820 m³/s

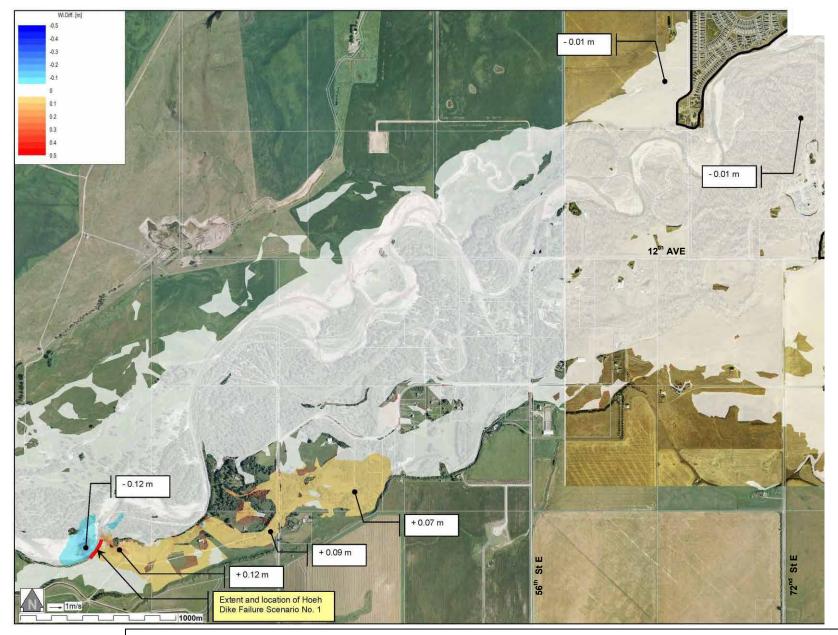
Hoeh Dike Failure Scenario 1 (150 m breach of upstream segment) – Water Level Increases (Scenario 28 A – 1,820 m³/s

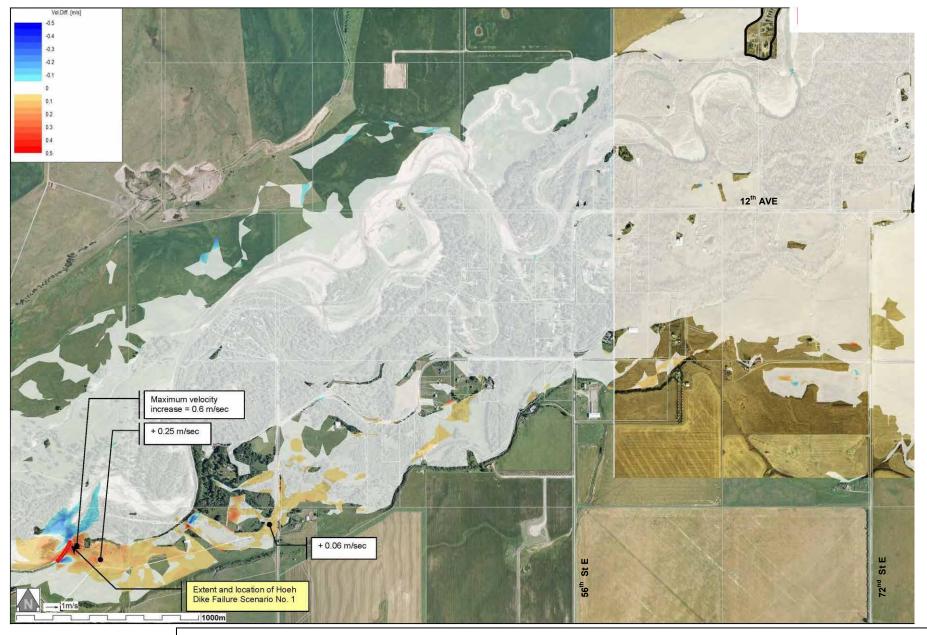
Hoeh Dike Failure Scenario 1 (150 m breach of upstream segment) – Velocity Increases (Scenario 28A) - 1,820 m³/s

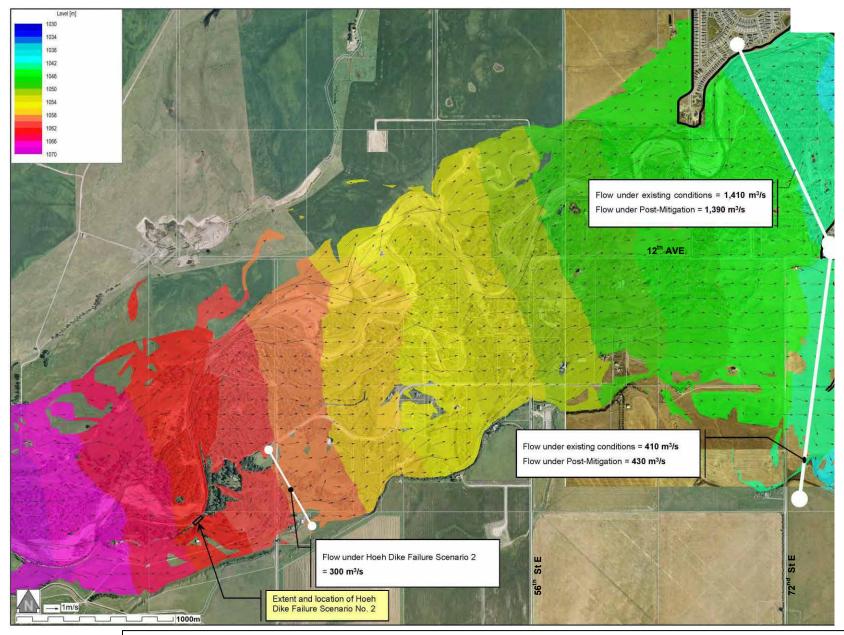
Figure No: 4.3.1

Hoeh Dike Failure Scenario 2 (50 m breach of downstream segment) – Peak Flow Summary (Scenario 28A) - 1,820 m³/s

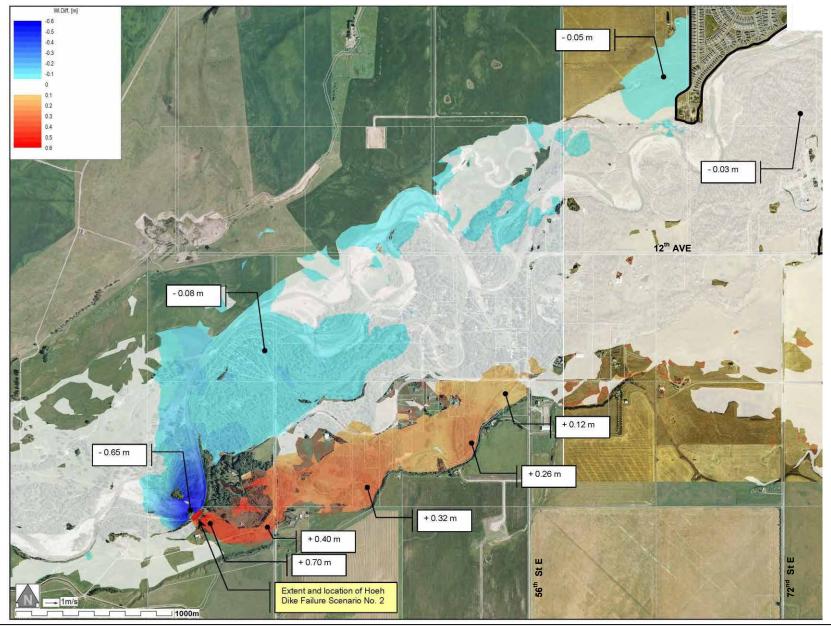
Figure No: 4.3.2

Hoeh Dike Failure Scenario 2 (50 m breach of downstream segment) – Water Level Increases (Scenario 28A) - 1,820 m³/s

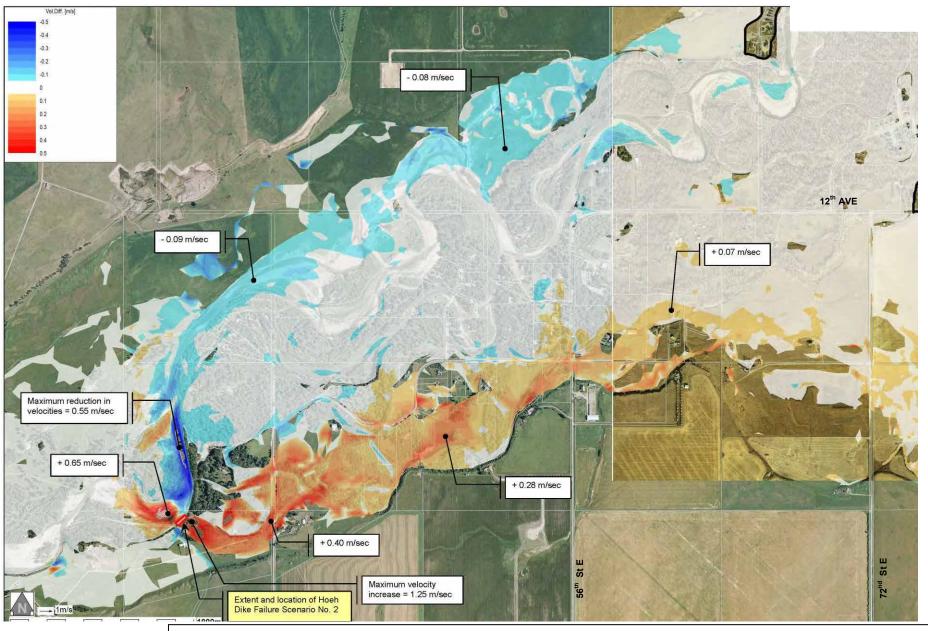
Figure No: 4.3.3

Hoeh Dike Failure Scenario 2 (50 m breach of downstream segment) - Velocity Increases (Scenario 28A) - 1,820 m³/s

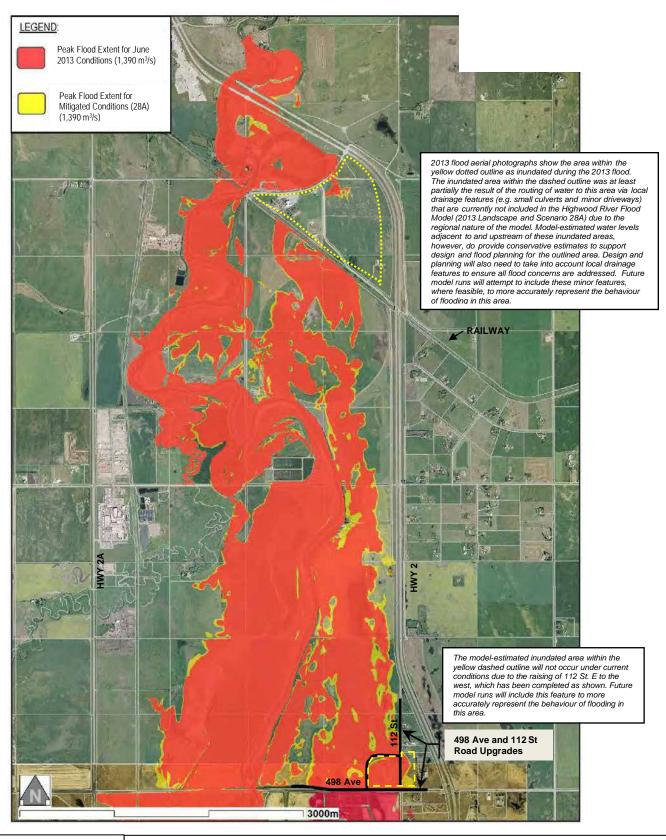
Figure No: 4.4.1

Highwood River – Predicted Inundation Extent Changes North of 498<sup>th</sup> Ave (Comparing 2013 Landscape Conditions to Scenario 28A) – 1390 m<sup>3</sup>/s

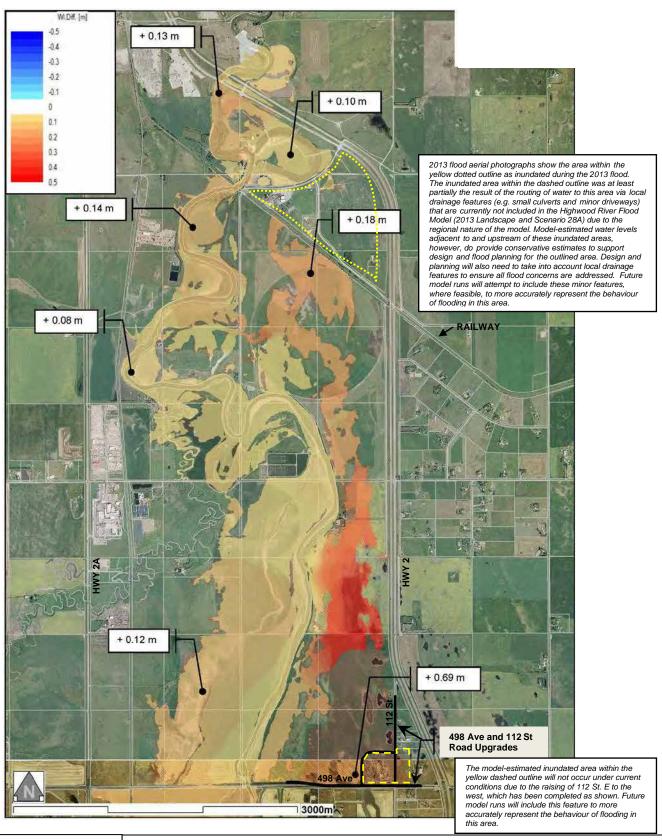
Figure No: 4.4.2

Highwood River – Predicted Level Changes North of 498<sup>th</sup> Ave (Comparing 2013 Landscape Conditions to Scenario 28A) - 1390 m<sup>3</sup>/s

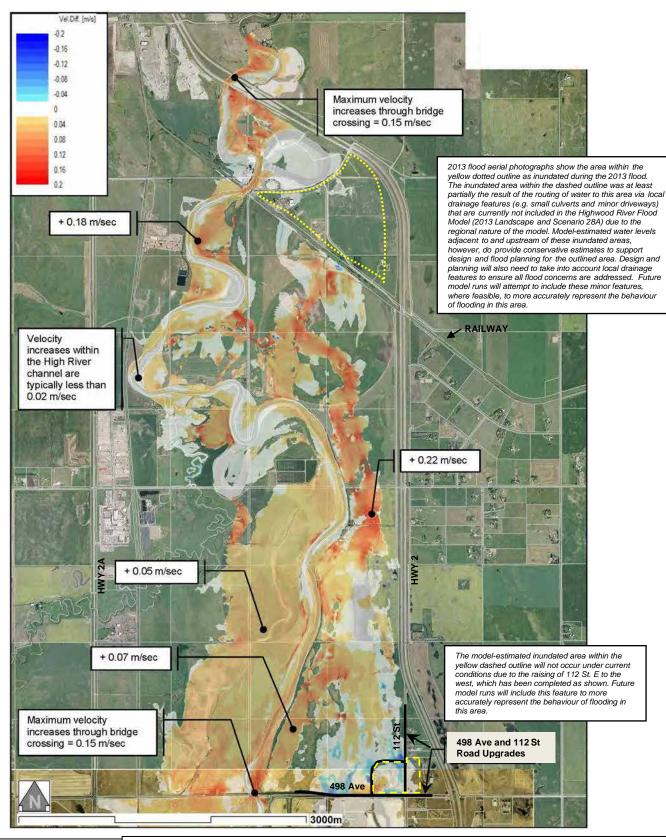
Figure No: 4.4.3

Highwood River – Predicted Velocity Changes North of 498<sup>th</sup> Ave (Comparing 2013 Landscape Conditions to Scenario 28A) – 1390 m<sup>3</sup>/s

Figure 4.4.3	Highwood River – Predicted Velocity Changes North of 498 Avenue E (Comparing 2013 Landscape Conditions to Scenario 28A) – 1,390 m <sup>3</sup> /s

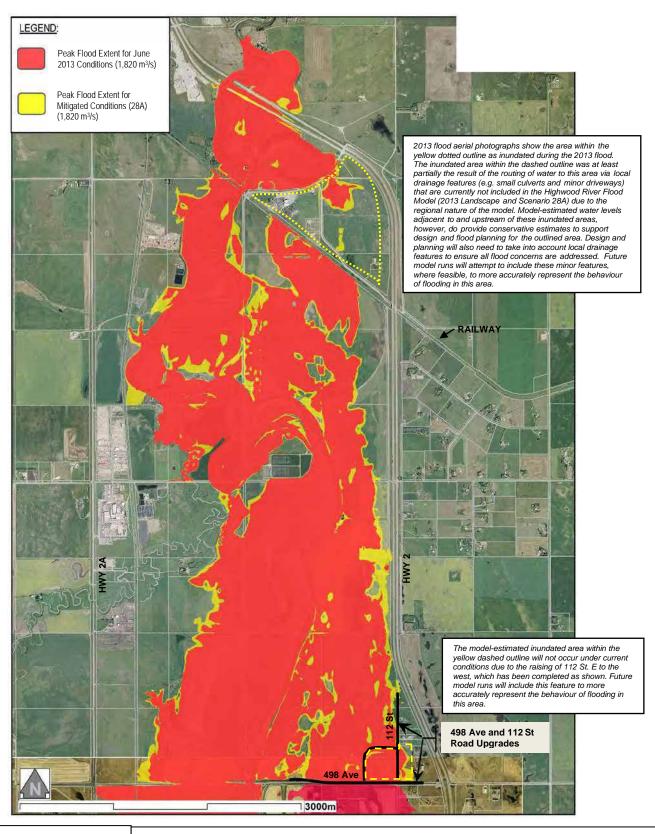
Figure No: 4.5.1

Highwood River – Predicted Inundation Extent Changes North of 498<sup>th</sup> Ave (Comparing 2013 Landscape Conditions to Scenario 28A) – 1,820 m<sup>3</sup>/s

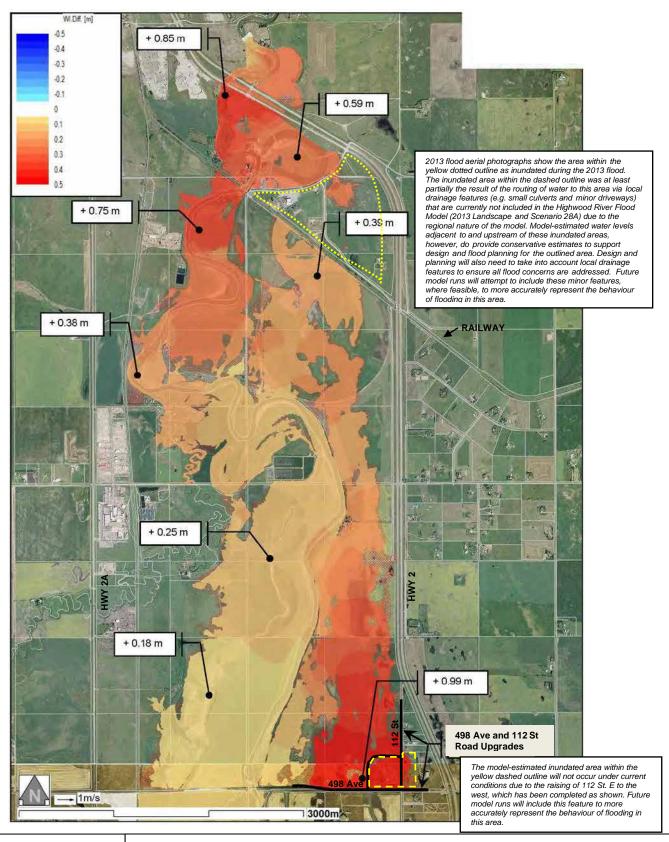
Figure No: 4.5.2

Highwood River – Predicted Level Changes North of 498<sup>th</sup> Ave (Comparing 2013 Landscape Conditions to Scenario 28A) – 1,820 m<sup>3</sup>/s

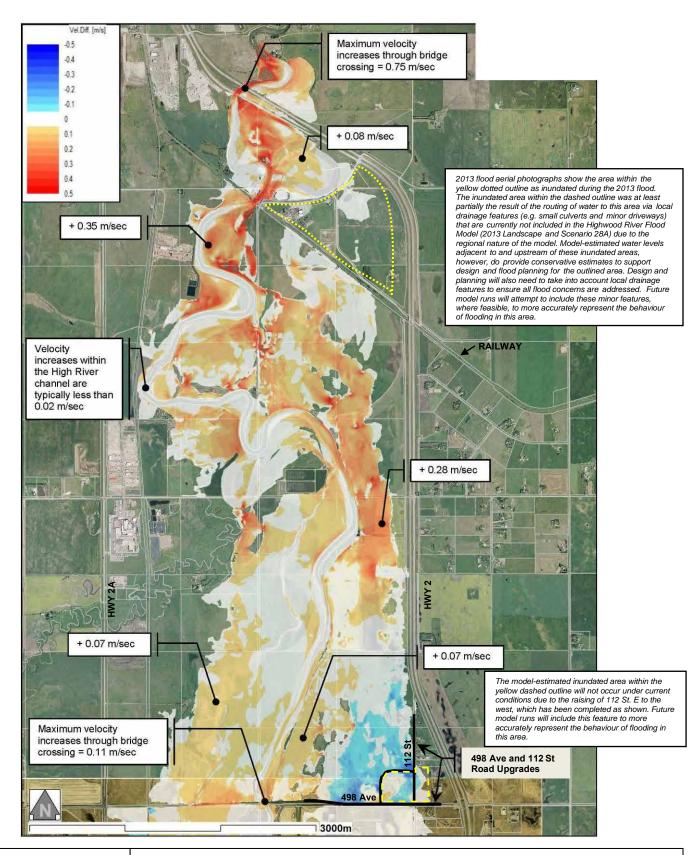
Figure No: 4.5.3

Highwood River – Predicted Velocity Changes North of 498<sup>th</sup> Ave (Comparing 2013 Landscape Conditions to Scenario 28A) – 1,820 m<sup>3</sup>/s

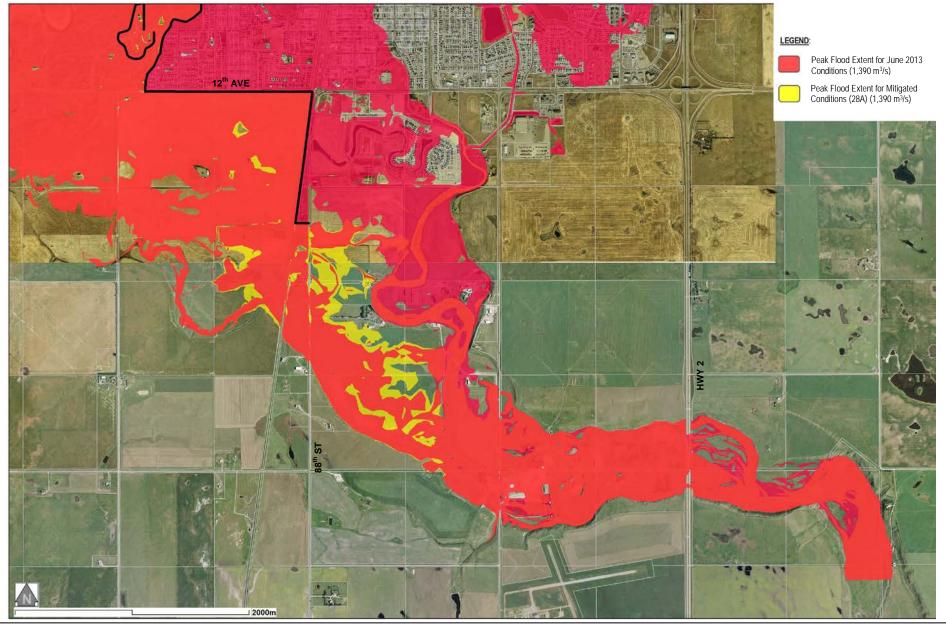
Little Bow River – Predicted Inundation Extent Changes South of 12<sup>th</sup> Ave (Comparing 2013 Landscape Conditions to Scenario 28A) – 1390 m<sup>3</sup>/s

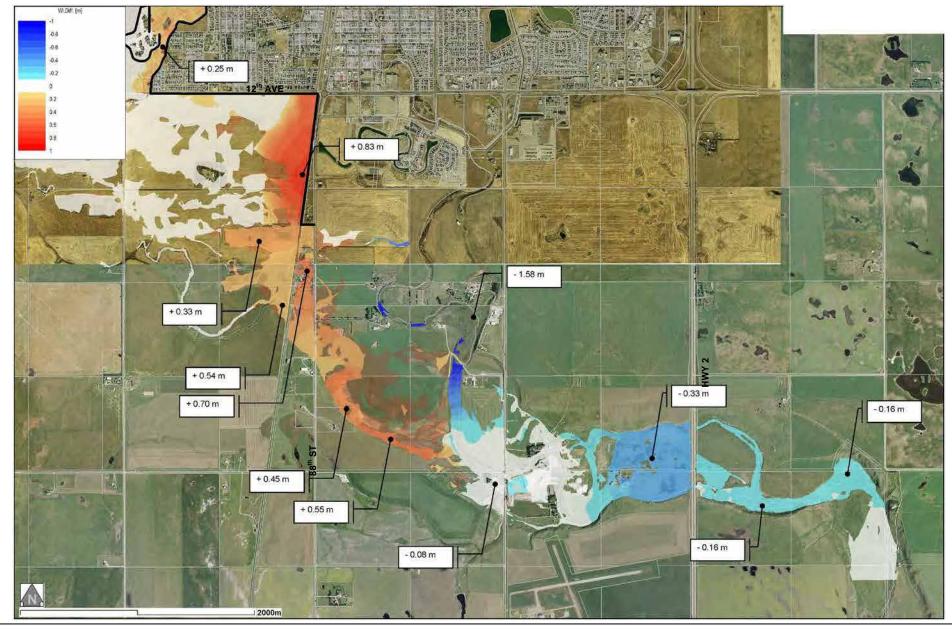
Little Bow River – Predicted Level Changes South of 12<sup>th</sup> Ave (Comparing 2013 Landscape Conditions to Scenario 28A) – 1390 m<sup>3</sup>/s

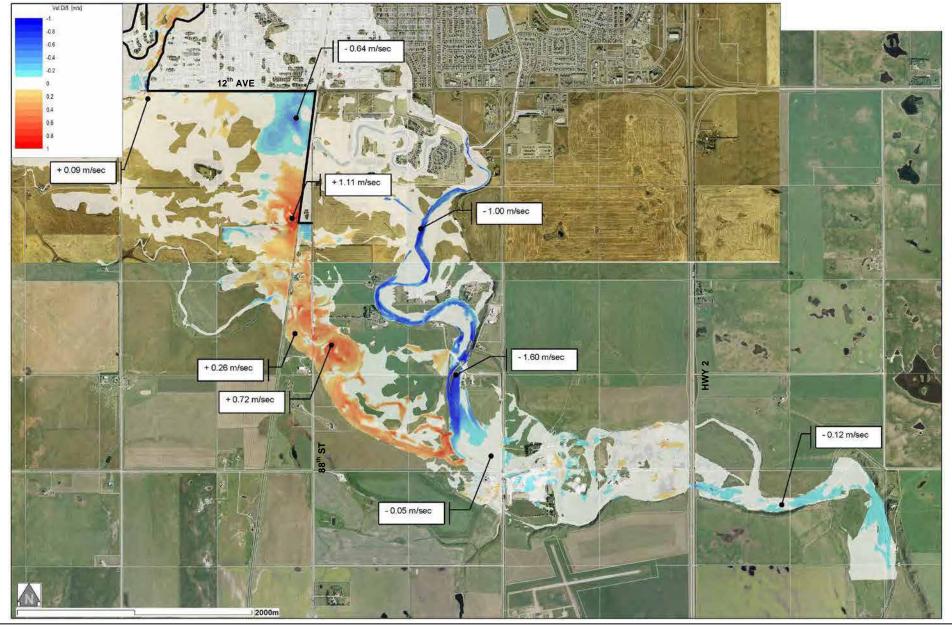
Little Bow River – Predicted Velocity Changes South of 12<sup>th</sup> Ave (Comparing 2013 Landscape Conditions to Scenario 28A) – 1390 m<sup>3</sup>/s

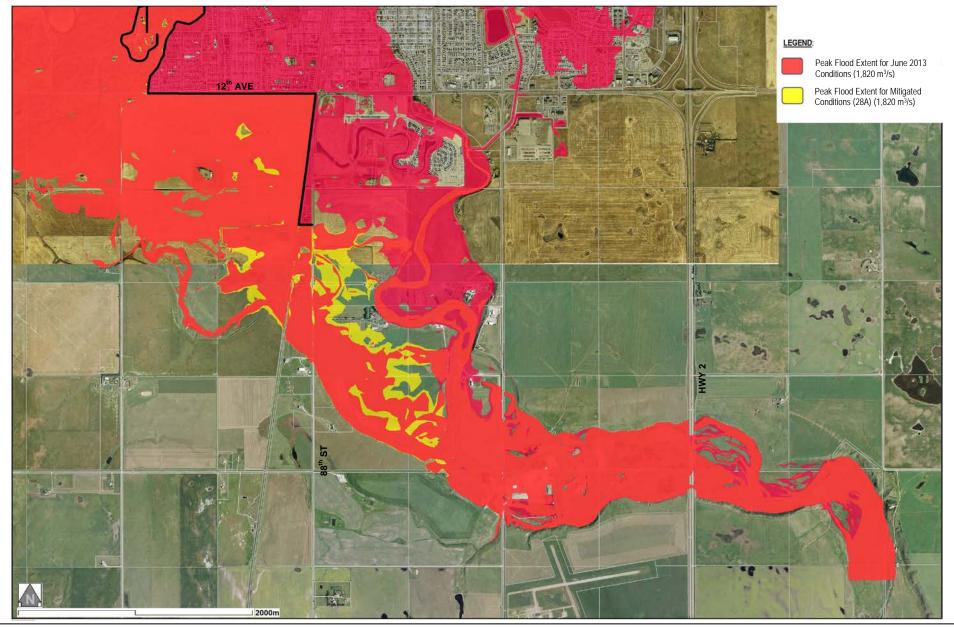
Little Bow River – Predicted Inundation Extent Changes South of 12<sup>th</sup> Ave (Comparing 2013 Landscape Conditions to Scenario 28A) – 1820 m<sup>3</sup>/s

Figure 4.7.1	Little Bow River – Predicted Inundation Extent Changes North of 498 Avenue E (Comparing 2013 Landscape Conditions to Scenario 28A) - 1,820 m <sup>3</sup> /s
Figure 4.7.2	Little Bow River – Predicted Level Changes North of 498 Avenue E (Comparing 2013 Landscape Conditions to Scenario 28A) – 1,820 m³/s
Figure 4.7.3	Little Bow River – Predicted Velocity Changes North of 498 Avenue E (Comparing 2013 Landscape Conditions to Scenario 28A) – 1,820 m <sup>3</sup> /s
Figure 4.8	Southwest Dike – Predicted Level Changes (Comparing 2013 Landscape Conditions to Scenario 38Ax [Removing Baker Creek Dike]) – 1,820 m <sup>3</sup> /s
Figure 6.1.1	Incremental Flood Damages and Mitigation Options – Highwood River – River Run (1 of 5)
Figure 6.1.2	Incremental Flood Damages and Mitigation Options – Highwood River – River Run (2 of 5)
Figure 6.1.3	Incremental Flood Damages and Mitigation Options – Highwood River – River Run (3 of 5)

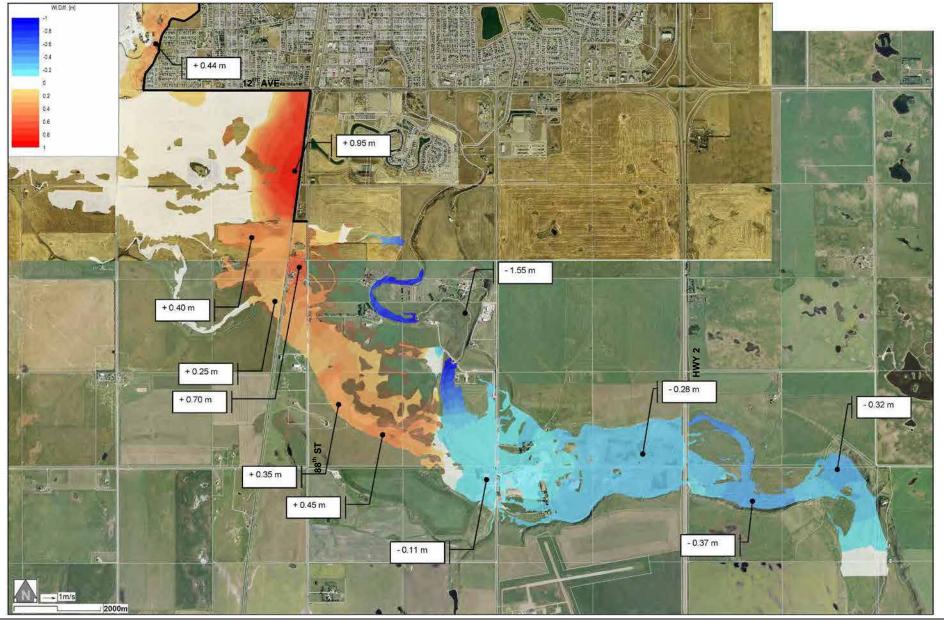
Figure No: 4.7.2

Little Bow River – Predicted Level Changes South of 12<sup>th</sup> Ave (Comparing 2013 Landscape Conditions to Scenario 28A) – 1820 m<sup>3</sup>/s

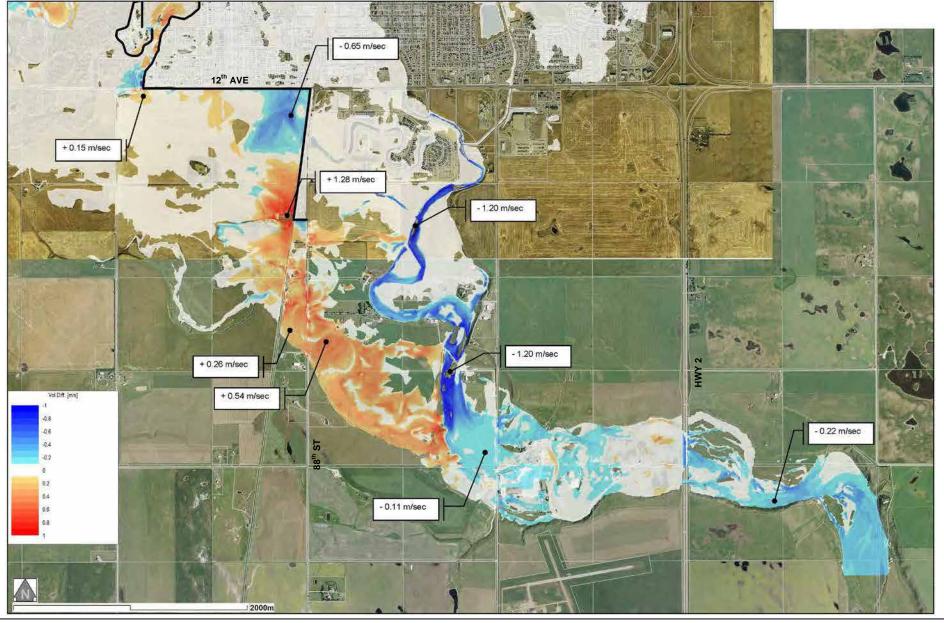
Little Bow River – Predicted Velocity Changes South of 12<sup>th</sup> Ave (Comparing 2013 Landscape Conditions to Scenario 28A) – 1820 m<sup>3</sup>/s

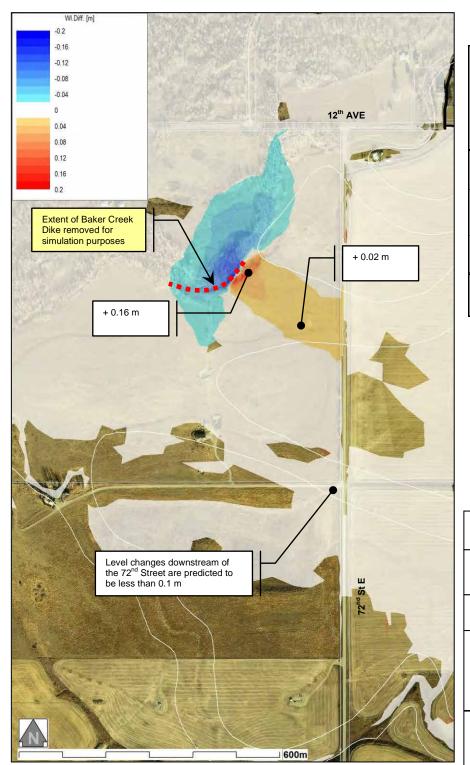
LOCATION	PREDICTED FLOW (m <sup>3</sup> /s) ^		
	EXISTING [2013 FLOOD LANDSCAPE]	28A [MITIGATED]	28Ax [28A + BAKER CREEK DIKE REMOVED]
HIGHWOOD RIVER -UPSTREAM TOWN	1,820	1,820	1,820
HIGHWOOD RIVER - DOWNSTREAM TOWN	1,222	<b>1,398</b> (+176)	<b>1,393</b> (+181)
LITTLE BOW RIVER	550	<b>402</b> (-148)	<b>407</b> (-153)
ATTENUATED FLOW	48	20	20

See Figure 1.3 for location of Baker Creek Dike in relation to study area.

Southwest Dike - Predicted Level Changes [Comparing 2013 Landscape Conditions to Scenario 28Ax (Removing Baker Creek Dike)] - 1,820 m<sup>3</sup>/s
